# Monitoring of the Weissmies Glacier before the Failure Event of September 10, 2017 with Radar Interferometry and High-Resolution Deformation Camera

Lorenz Meier<sup>1</sup>, Mylène Jacquemart<sup>1</sup>, Richard Steinacher<sup>1</sup>, Dominik Jäger<sup>1</sup>, Martin Funk<sup>2</sup>

<sup>1</sup> Geopraevent AG, Technoparkstrasse 1, 8005 Zurich, Switzerland  
<sup>2</sup> ETH Zurich, Laboratory of Hydraulics, Hydrology and Glaciology, 8093 Zurich, Switzerland

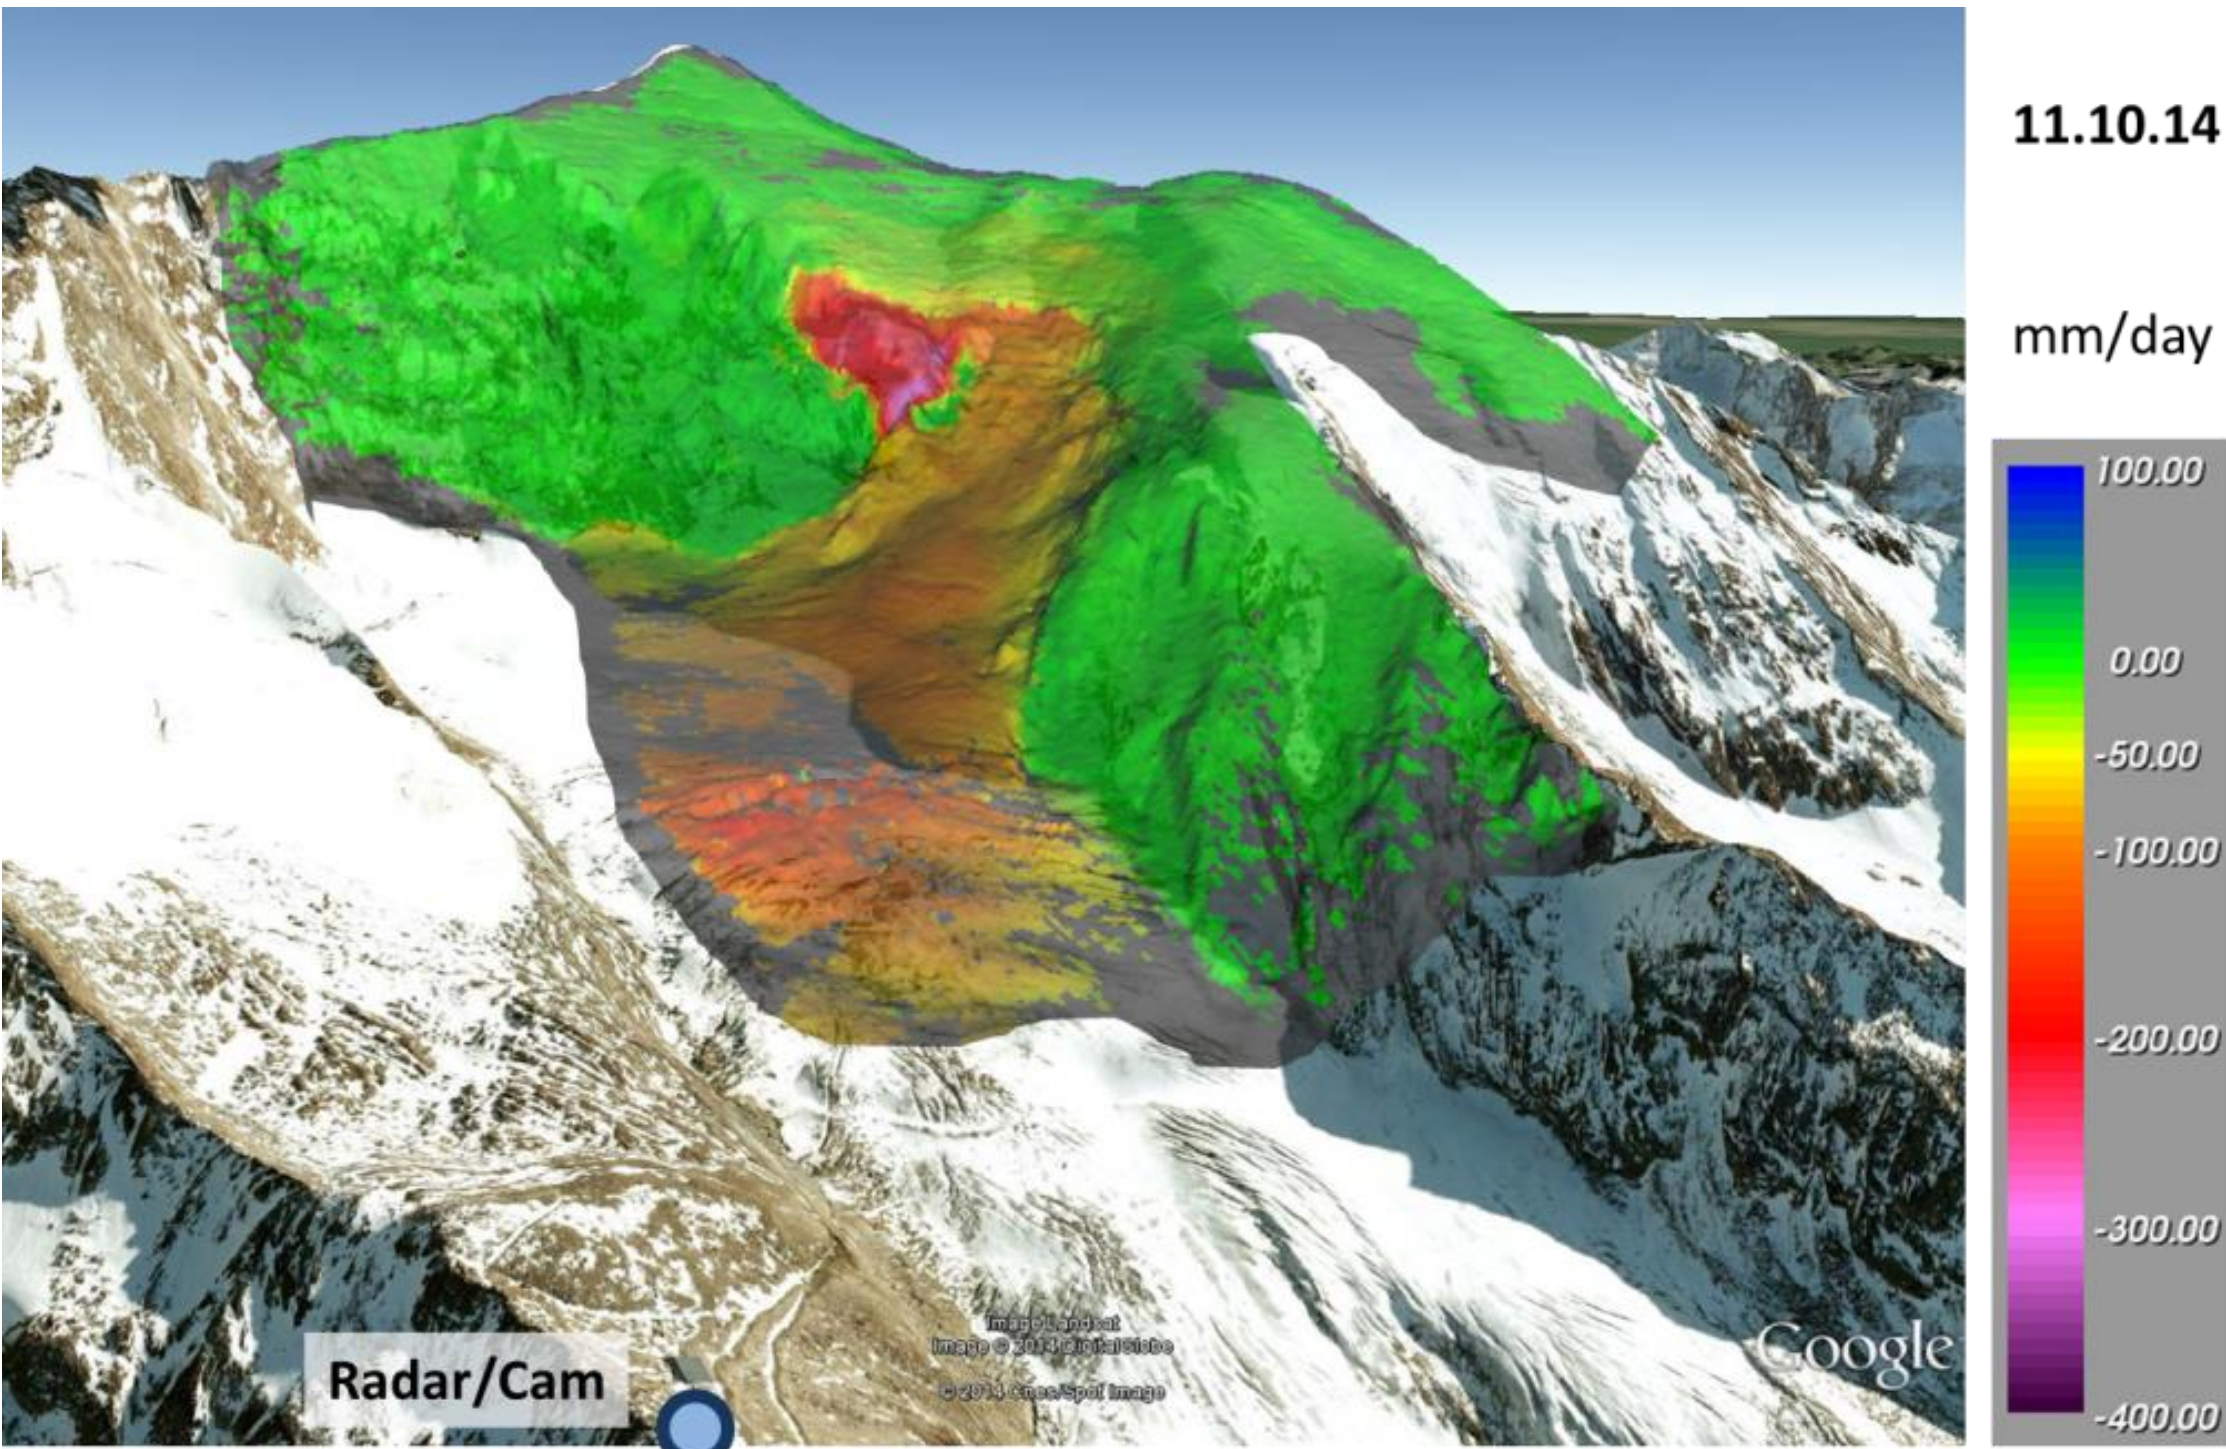
Figure 2: Visualisation of the radar coverage. Whereas the rocky part is stable, the radar detects velocities around 20 cm/day at the glacier surface in October 2014.

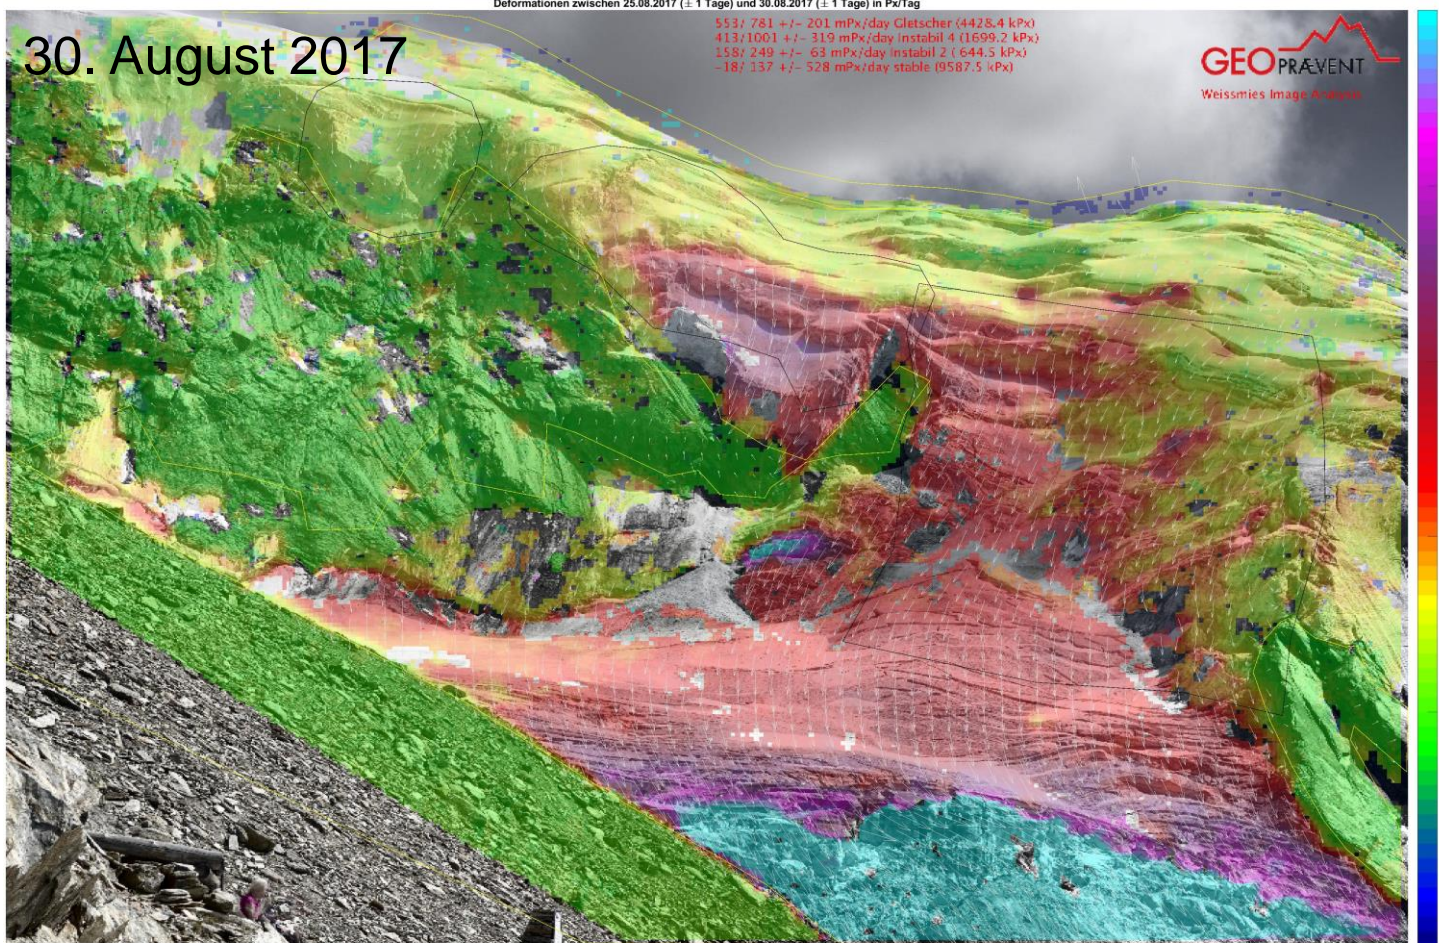
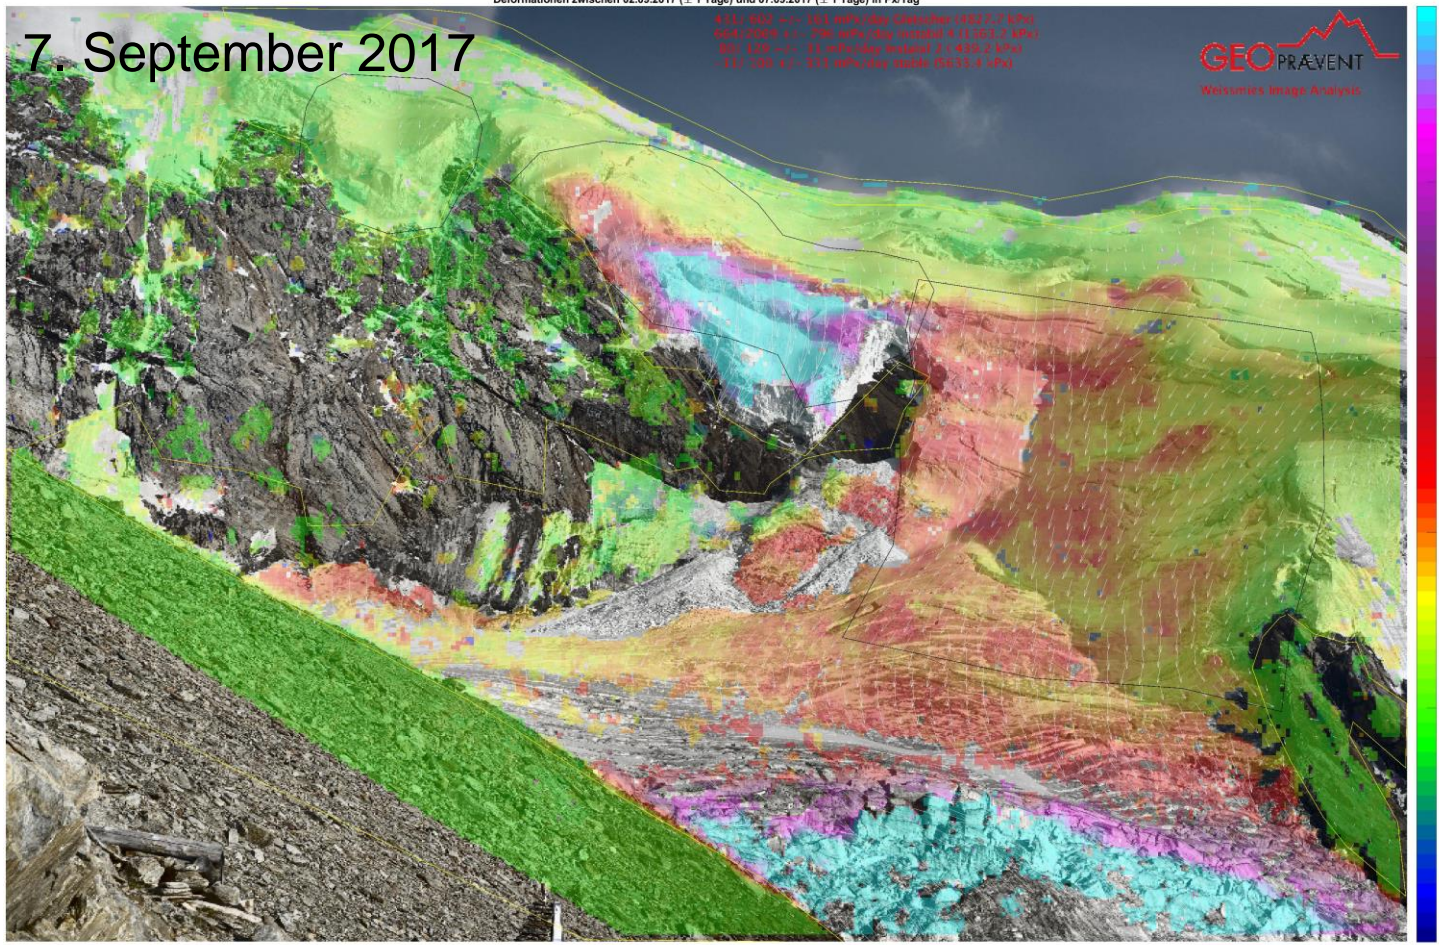
In August 2017, a **pronounced acceleration** was observed on the **camera analysis**. Therefore, we re-installed the interferometric radar. The radar measurements confirmed the 5-fold increase in surface velocities. Around noon on September 9, extrapolation of the inverse velocities predicted a large failure within approximately 24 hours. As a consequence, 220 inhabitants of Saas Grund were evacuated. In the early morning of September 10, the collapse of a total of approximately 300'000 m<sup>3</sup> happened, luckily not at once but in several smaller portions during about 10 minutes.

Figure 3: An image processing algorithm **automatically** determines the surface deformations based on the camera pictures.

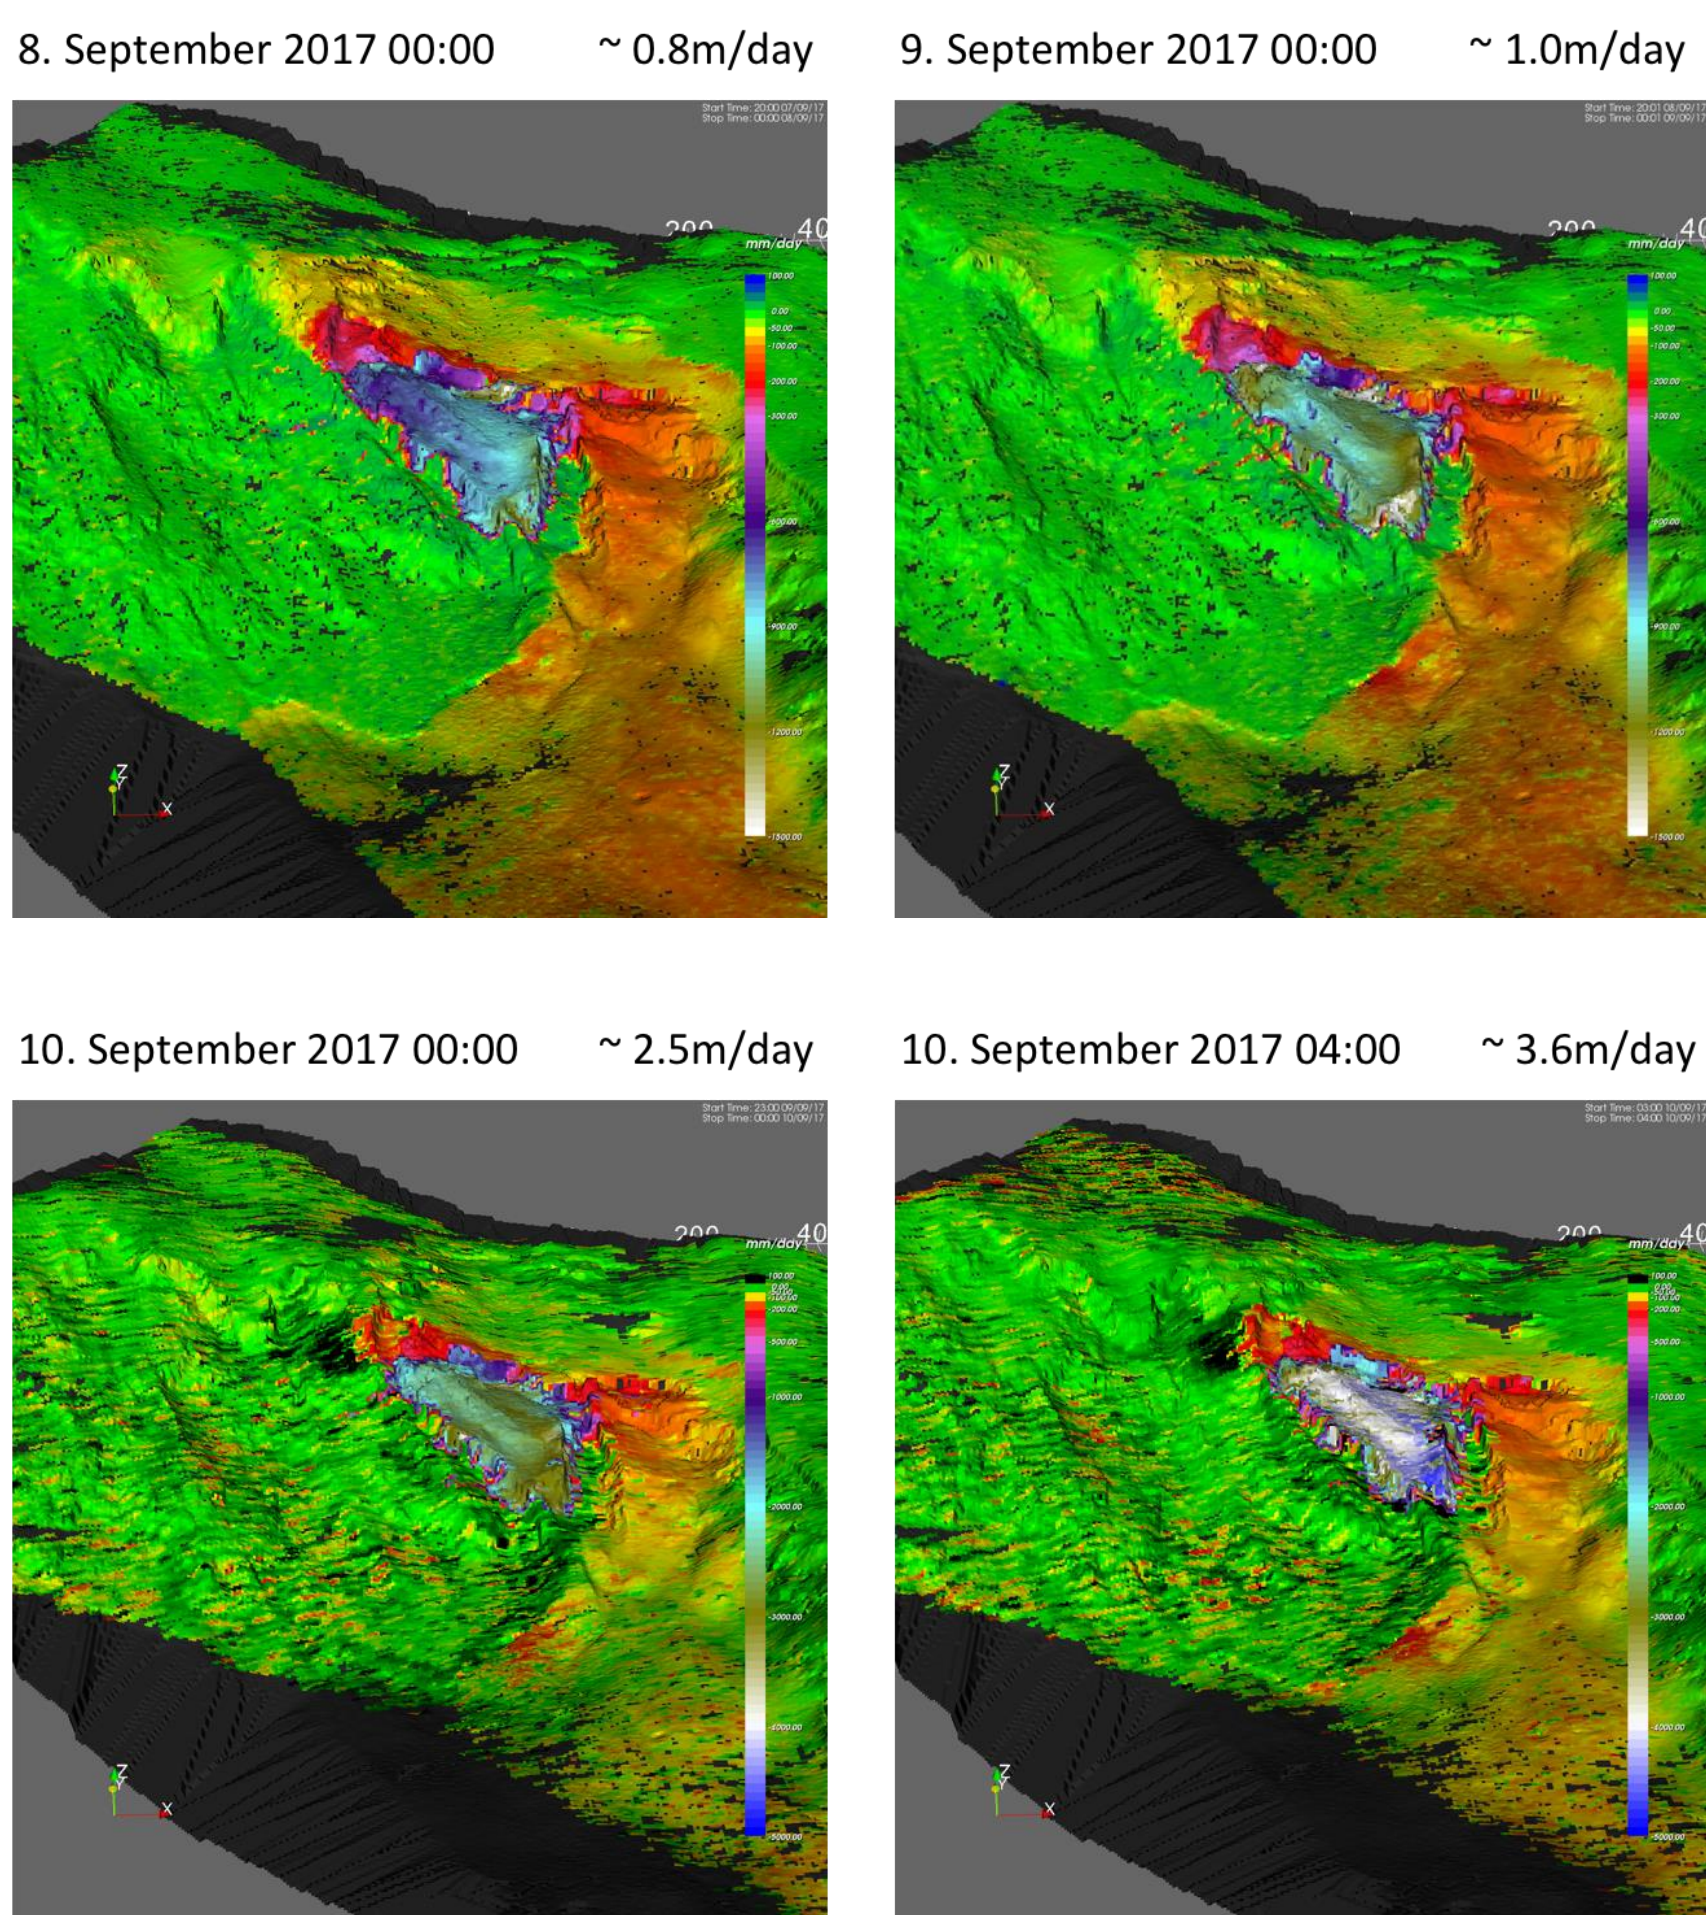
Figure 4: Development of surface velocities as measured by the radar on the unstable part of the glacier during the two days prior to failure.

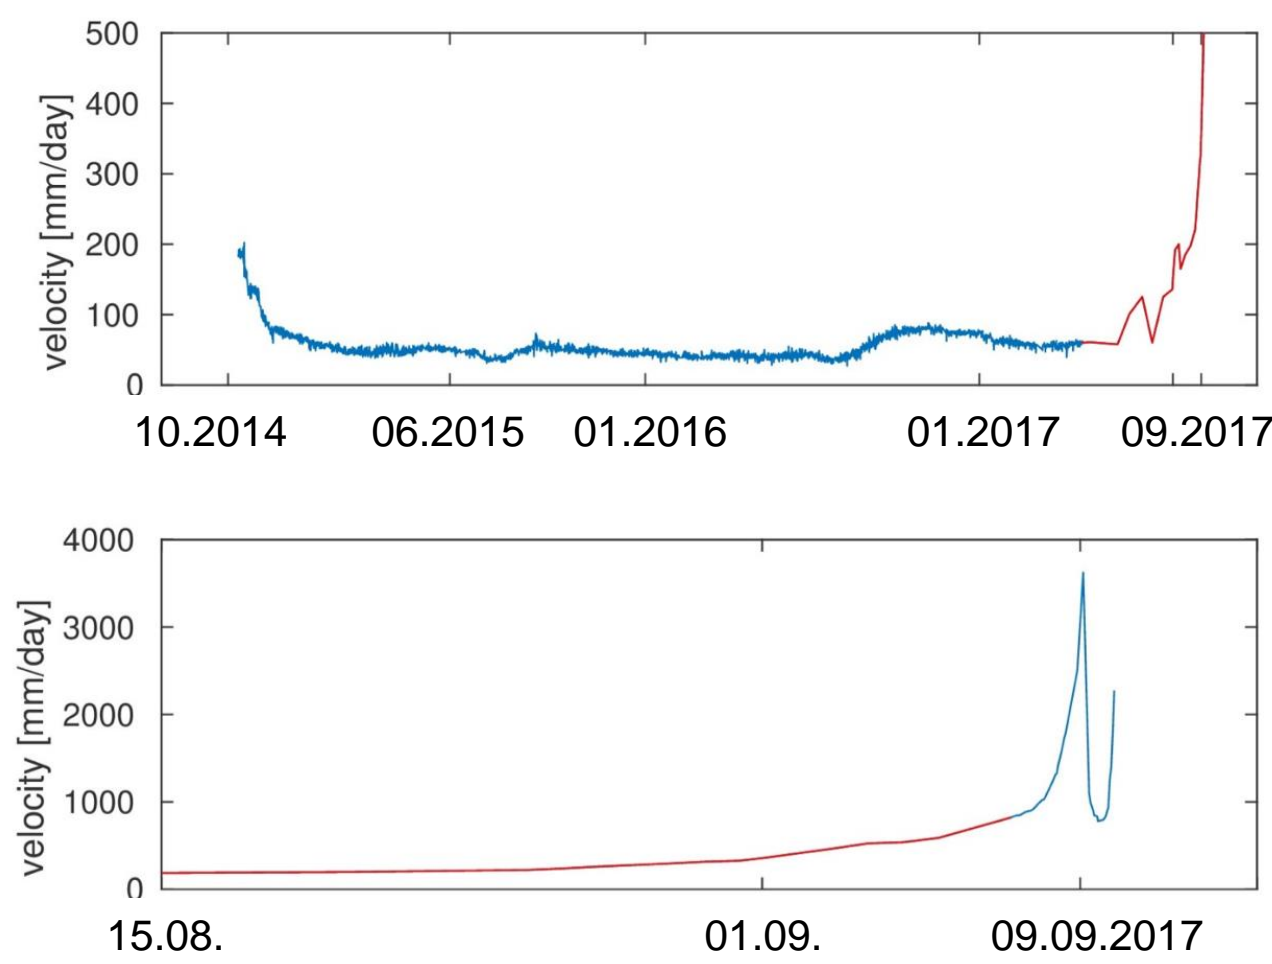
Figure 5 (left): Surface velocities measured since October 2014. Radar measurements are plotted in blue, velocities measured with the high-resolution camera system are plotted in red.

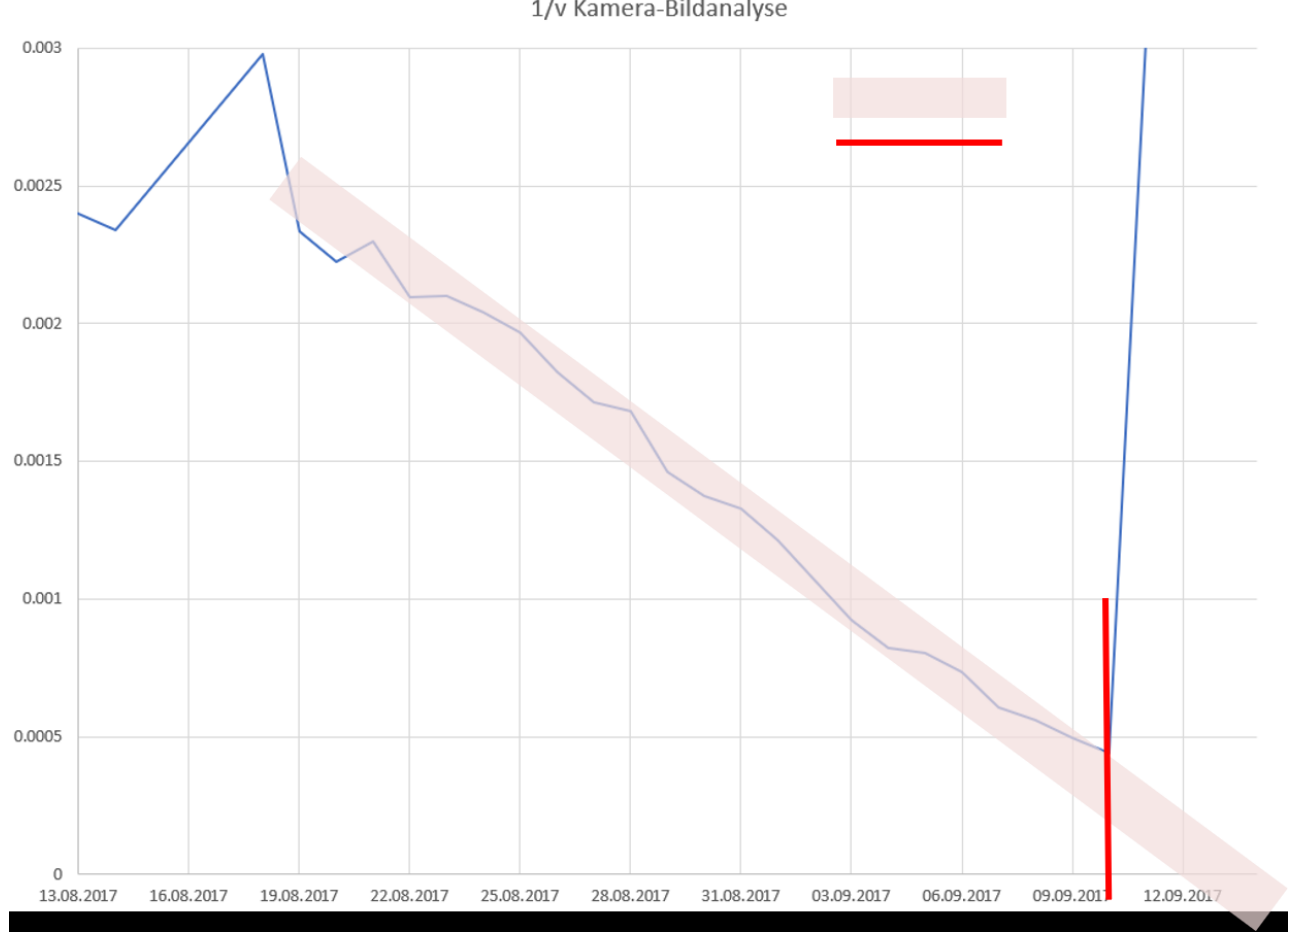
Figure 6 (right): Inverse plotting of the velocities measured since mid August 2017 by the camera.

Already by the end of August it was clear that a failure would happen within a few weeks.
