Monitoring of the Weissmies Glacier before the Failure Event of September 10, 2017 with Radar Interferometry and High-Resolution Deformation Camera

Lorenz Meier¹, Mylène Jacquemart¹, Richard Steinacher¹, Dominik Jäger¹, Martin Funk²

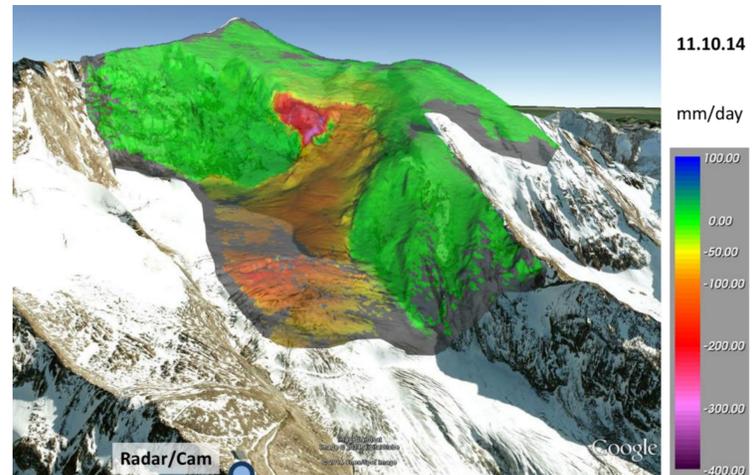
Figure 2: Visualisation of the radar coverage. Whereas the rocky part is stable, the radar detects velocities around 20 cm/day at the glacier surface in October 2014.

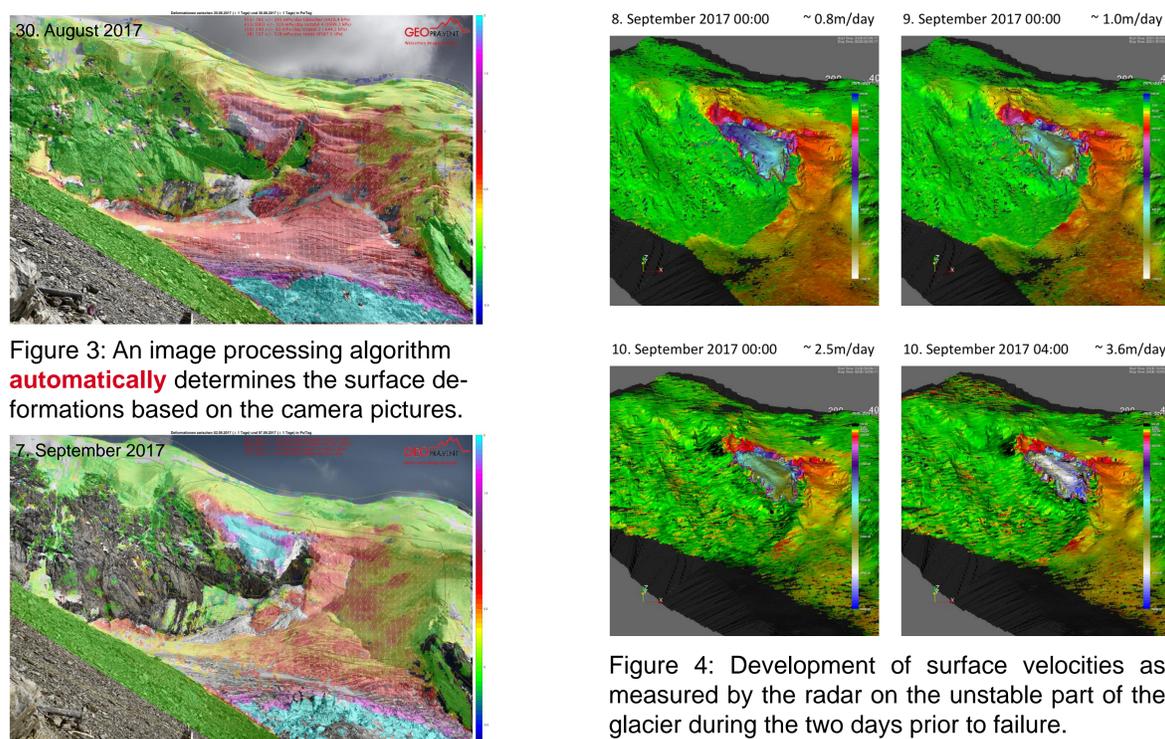
In August 2017, a **pronounced acceleration** was observed on the **camera analysis**. Therefore, we re-installed the interferometric radar. The radar measurements confirmed the 5-fold increase in surface velocities. Around noon on September 9, extrapolation of the inverse velocities predicted a large failure within approximately 24 hours. As a consequence, 220 inhabitants of Saas Grund were evacuated. In the early morning of September 10, the collapse of a total of approximately 300'000 m³ happened, luckily not at once but in several smaller portions during about 10 minutes.

Figure 4: Development of surface velocities as measured by the radar on the unstable part of the glacier during the two days prior to failure.

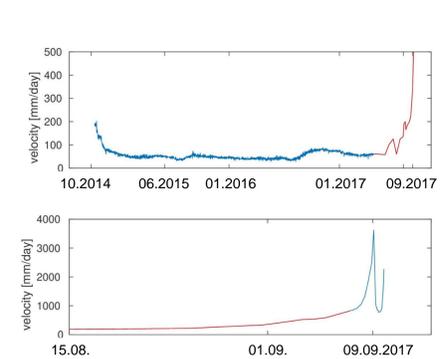
Figure 5 (left): Surface velocities measured since October 2014. Radar measurements are plotted in blue, velocities measured with the high-resolution camera system are plotted in red.

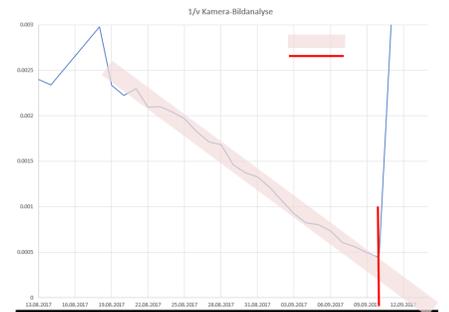
Figure 6 (right): Inverse plotting of the velocities measured since mid August 2017 **by the camera**.

Already by the end of August it was clear that a failure would happen within a few weeks.
