ROCKFALL MONITORING PREONZO

Detailed monitoring and analysis of rock movements by interferometric radar before large rockfall in Preonzo.

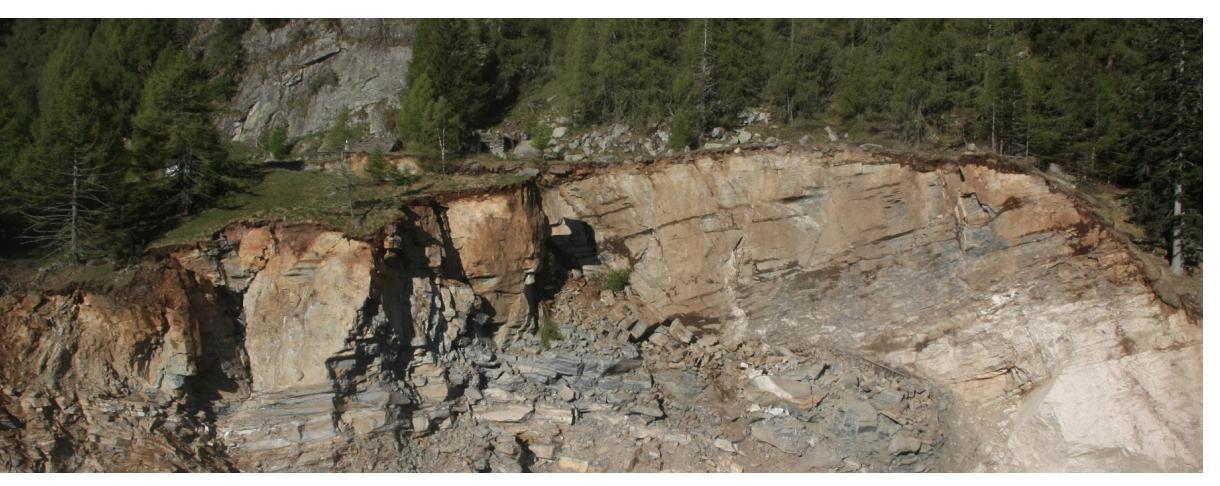
Figure 1: On 15 May, approx. 220,000 m³ of rock debris fell down into the valley.

In the early hours of May 15, approx. 220,000 m3 of rock plunged down the valley for several hours and fortunately did not cause any damage. However, half of the potentially unstable material had remained at the top. Were further events to be expected? How extensive were movements after the first part of the landslide? Since most of the originally mounted monitoring equipment had been destroyed during the event, the interferometric radar had to deliver the answers. We could give an all-clear few hours after the main fall. Some parts of the rupture zone were still moving, but were coming to a halt fast. Secondary rockfall was not to be expected, our work was completed.

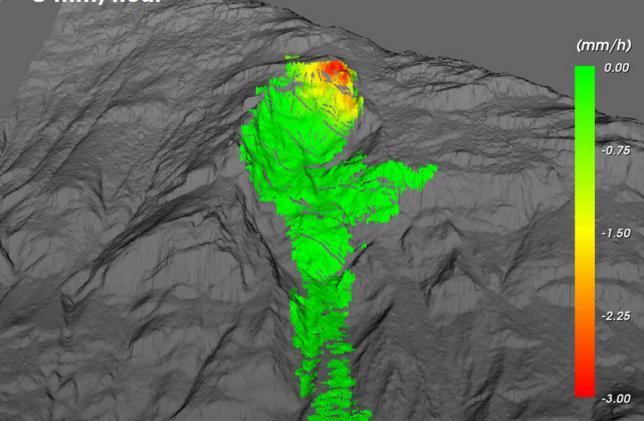
Figure 2: Georadar view: The moving rock mass contains an area of 100 $\rm x$ 200 m.
