ROCK AVALANCHE AND DEBRIS FLOW ALARM SYSTEM BONDO

Comprehensive rock avalanche monitoring at Pizzo Cengalo and debris flow alarm system with automatic road closure in Bondo village.

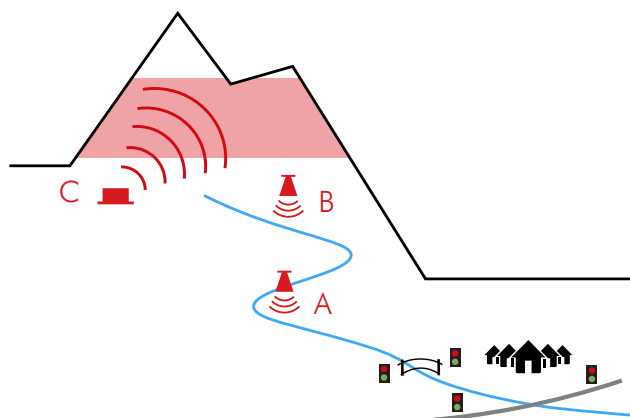
Debris flow alarm stations (A, B) with gauge radars, webcams and alert and rock avalanche warning system (C) with georadar and webcam.

The existing alarm station (station A) was repaired and extended. In addition, we installed a second alarm station upstream (station B) allowing increased warning times. Station A provides approximately two minutes and station

B approx. four minutes warning time before the debris flow reaches the village. The clean-up area and bypass road were equipped with traffic lights, alarm horns and worker beacons. The mobile alerting devices can be moved any time or made permanent once the works are completed.

Additionally, we set up a warning system to monitor Pizzo Cengalo around the clock by georadar (station C). The interferometric georadar continuously scans the rock face and detects smallest surface movements on a scale from millimetres per year to meters a day. The radar operates reliably at a safe distance in all weather and visibility conditions. Automated deformation analysis identifies acceleration areas within the rock face and enables early recognition of potential instabilities. Collapse estimations can be drawn from analysing the inverse velocities of critical rock areas combined with expert judgement. Event predictions including approximate timings have proved correct in several cases, e.g. for the rockfall event of September 15, 2017, with expected failure at night. The georadar warning system allows to plan and implement appropriate protection measures early (e.g. evacuation) and guarantee safety for the village.

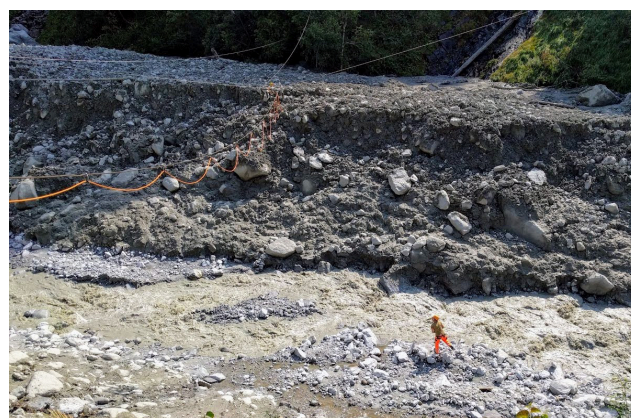
Gauge radar station (station A) across the Bondasca river with several meters debris flow deposits in August/September, 2017.
