ROCKFALL GURTNELLEN

Rock monitoring system with georadar and various cleft measurement devices after large rockfall event affecting the main North-South route of the Swiss Federal Railway near Gurtellen.

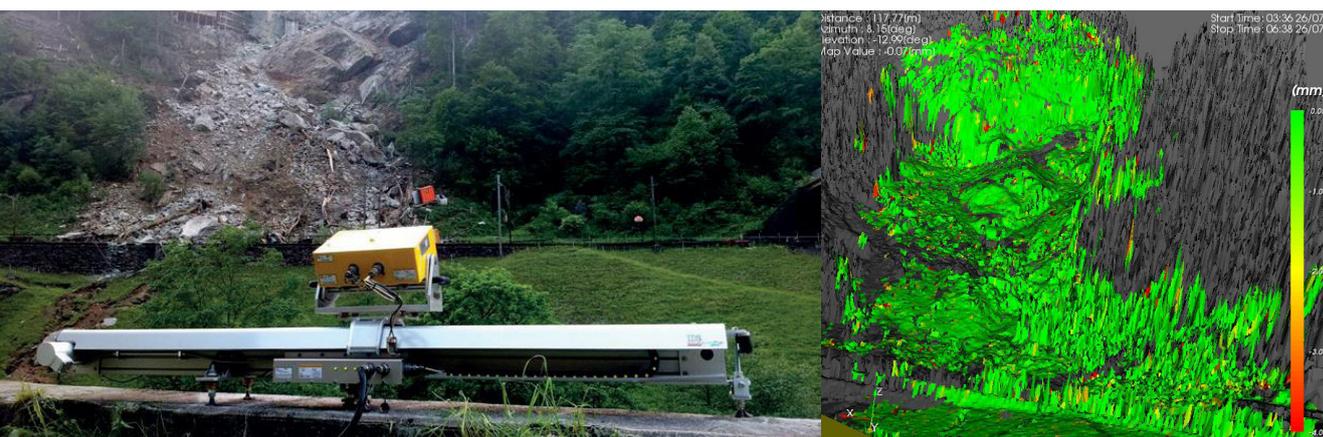
After the rockfall, the georadar was installed to monitor the rock face. On the right is the view of the georadar: Rock deformations in the millimetre range can be detected for the whole wall.

Together with geologists of the Swiss Federal Railways and GEOTEST AG, Geopraevent reached the rock fall site around noon on June 5, 2012. The interferometric georadar was immediately transferred to the Gurtellen site. Thanks to its simple installation and the independent power supply, it was ready to conduct the first measurements around 8pm that same day – and provide a first assessment of the remaining danger of secondary falls. During the three following days of recovery works Geopraevent was constantly present, analysing the radar data first-hand so that works in the danger-zone could have been stopped at the first sign of shifts in the wall.

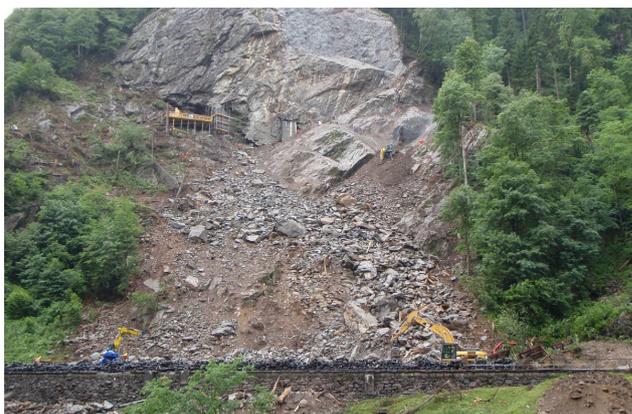
The Gotthard Railway Line was buried under piles of debris after a security blasting.

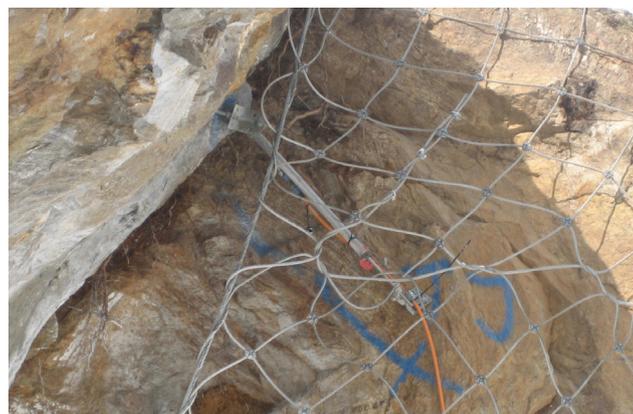
Permanently installed telejointmeters determine the width of cracks in the rock with high accuracy to enables the detection of movements.

- Six trifold extensometers at depths of up to 40m.
- More than ten telejointmeters monitored movements of single blocks and clefts.
- Trigger lines woven into the temporary safety nets which automatic trigger alarms.
- Over 50 geodetic reference points (operated by our partners, data available on the online data portal)
- Permanent operation of our interferometric radar.
