Automatic Deformation Analysis with Cloud Processing of High-Resolution Images with Examples of Veslemannen (Norway) and Trift Glacier (Switzerland)

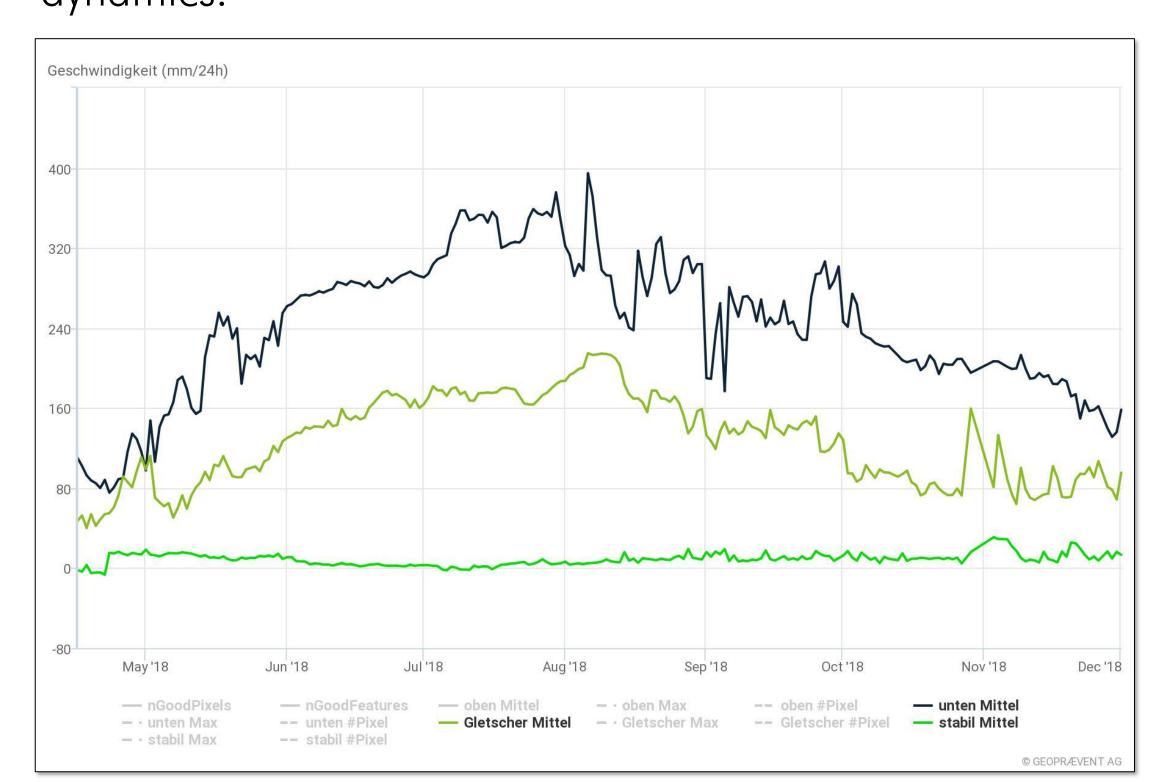
We developed a fully automatic deformation analysis based on high-resolution images, smart image selection and proprietary evaluation algorithms. The camera system consists of a 42-MP camera, autonomous power supply and data transmission to our cloud. Several times a day, the system triggers images and uploads them to our cloud where a selection algorithm eliminates unsuitable images (e.g. due to weather, exposure) by analysing image characteristics. The best image combinations for a given interval are determined based on maximum attribute match. Automatic selection is vital for process automation and is a key features of our application compared to conventional image analysis based on manual selection. Image analysis is based on cross correlation and runs for several hours on our highperformance computers. The 2D-deformation analysis is projected onto an image and shows the displacement colour-coded including movement direction. In addition, we calculate time series of defined image fields providing an overview of long-term surface displacement dynamics.
