ROCKFALL RADAR BRIENZ/BRINZAULS

Rockfall radar alarm system with automatic road closure in the landslide area near the Swiss village of Brienz/Brinzauls.

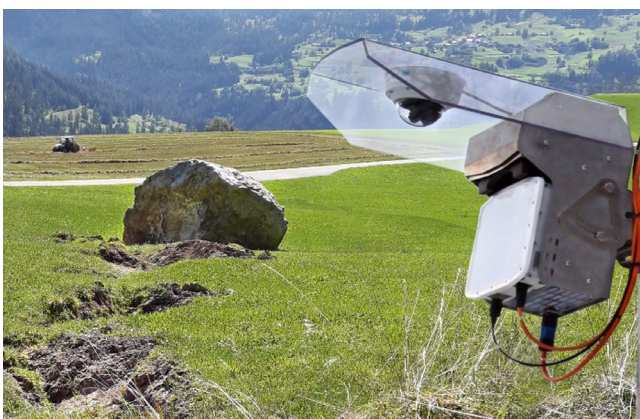
Figure 2: The rockfall radar detects falling rocks and automatically activates a webcam which takes pictures of the event.

In addition, the rockfall radar activates the system-integrated webcam for automatic recording of the event. Authorized users can access all event data and images at any time using the online data portal via PC, tablet or smartphone. The rockfall event is displayed on a map including corresponding event images and key parameters (e.g. duration and speed). Following a test phase, automatic closure of the exposed road section went into operation in mid-December 2018. Since initial installation of the Rockfall Radar, more than 5000 events with boulders of various sizes have been detected. However, only a few of these boulders reached as far as the road or even crossed it and led to longer closures.

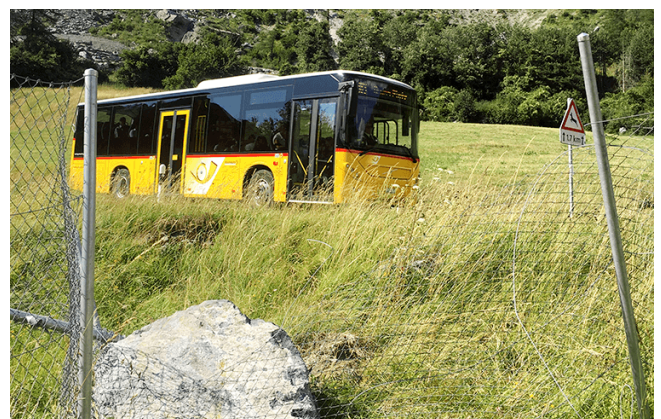
Figure 3: Automatic closure of the road when a rockfall is detected increases safety on the road.

independently of prevailing visibility conditions, day/night as well as during fog or snowfall. The radar immediately triggers an alert upon rockfall detection and automatically switches the traffic lights to red and notifies the responsible safety managers. Once the radar detected rockfall, it tracks the course of the boulders until they stop or move out of the radar's field of view. In order to prevent long and unnecessary closures, the road automatically reopens after 2 min if the boulder does not reach the road area.
