ROCKFALL ALARM SYSTEM GUMPISCH VALLEY

An alarm system with different measuring sensors monitors the Axenstrasse in the Gumpisch Valley, one of the most important North-South corridors in Europe.

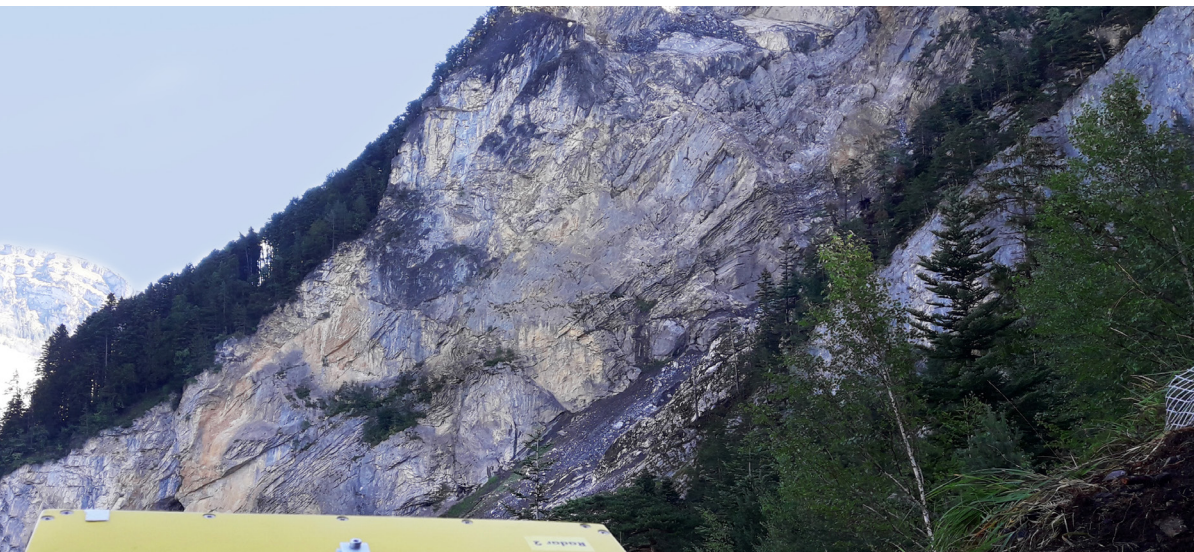
Figure 1: The interferometric georadar permanently scanned the site of the January 2019 rockfall event from the Plattwald site.

Interferometric georadar measurements were carried out from various locations to ensure that the January 2019 rockfall site in the upper Gumpisch was no longer unstable and at risk of failing again. We installed the georadar for permanent measurements at a suitable location in the forest above the road and operated the instruments with a fuel cell and solar panels autonomously for 6 months. In addition, we performed periodic measurements of the entire Gumpisch ridge from the opposite lake shore, at the village of Bauen.

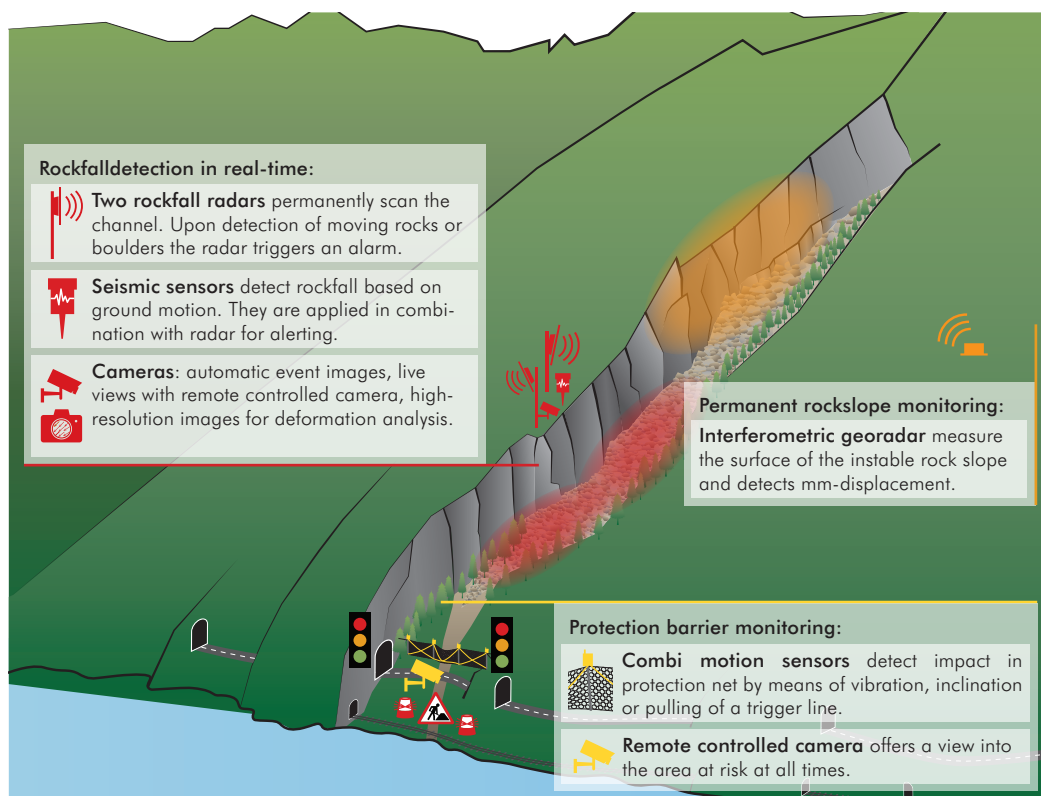
Figure 2: Overview of the monitoring system Gumpisch Valley with three stations: Rockfall detection (red), rock monitoring (orange, temporary) and protection barrier monitoring (yellow).

The monitoring system in the Gumpisch valley is tailored to the local hazard situation and consists of various sensors and cameras at different locations. The key elements of the system are two rockfall radars at the Buggistäfeli site about 400 height metres above the road. They permanently monitor the debris accumulations and automatically detect moving rock masses in real time, no matter whether it is a debris flow or large individual blocks. Radar works in all visibility conditions; at night, in fog or snowfall. At the same time, three seismic sensors at the same location measure ground vibrations and detect rockfall or a debris flow through the generated ground movement. The sensor fusion of both technologies allows for maximum detection reliability and, at the same time, a minimum number of false alarms. Our algorithms detect an event by certain combination of sensor signals in real-time and automatically switch the traffic lights at road below to red. Until December 2019, the SBB (Swiss Federal Railways) construction site further downslope was also alerted with alarm horns.

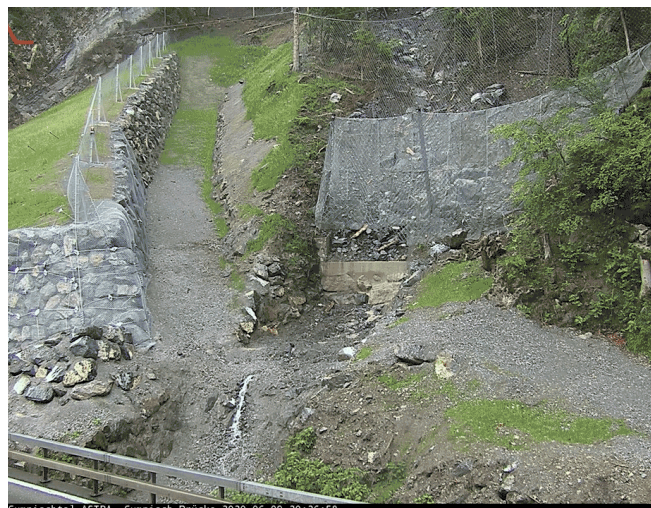
Figure 4: Rockfall dam with attenuator protection net.

The warning time for a rockfall event at this site is short: about 20 to 50 seconds elapse between movement detection and the boulder arriving at the road. Therefore, the road must be closed as soon as possible upon event detection. But not every moving boulder reaches as far as the road. Many of them come to a halt further up and remain in the debris channel. Therefore, we equipped the protection barriers above the road with combined motion sensors; the small, robust sensors detect an impact or

passage of a boulder either by the induced vibration or by pulling the integrated trigger line. If it remains calm in the protection barriers upon detection of a moving boulder by the radars at Buggistäfeli, the traffic lights automatically switch back to green after two minutes. In case the motion sensors detect an impact even in the vicinity of the road, the road remains closed for the time being and an expert team of geologists is automatically notified to survey the situation via webcams – and if necessary on site. Once road safety is ensured again, the road will be released for traffic again.

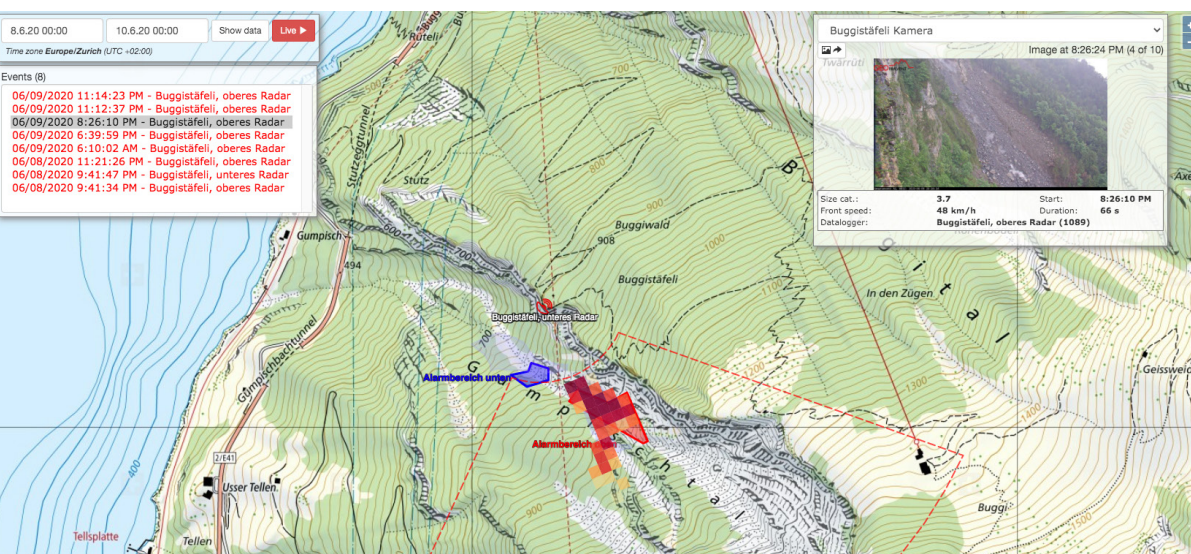
Figure 5: The rockfall radar tracks the detected movement and draws the event onto an online map. The rockfall map displays all events including event images and additional parameters, such as average speed or duration of the event within the radar's field of view.
