## AVALANCHE RADAR HOLMBUKTURA

State-of-the-art, remote avalanche alarm system for real-time detection of triggered and spontaneous avalanches at up to 4 km distance in Northern Norway.

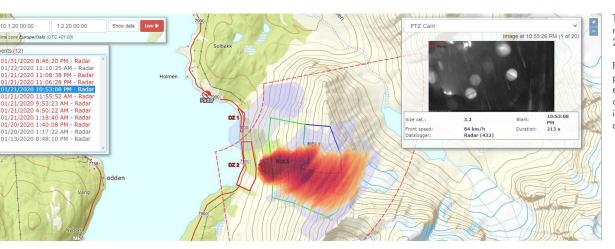
Figure 1: Online data portal: Avalanche map with event list and avalanche characteristics including image series (if visibility allows).

width of the fjord. Simulations for the Holmbuktura area revealed the northern bay side as ideal location for a long-range avalanche radar. We developed a radar solution with reach of up to 4 km to guarantee maximum slope coverage. The radar opening angles of 90° horizontally and 15° vertically allow for coverage of an even larger than the region of interest – in total 4 km². The setup includes a PTZ-camera (Pan-Tilt-Zoom) that automatically captures avalanches or smaller events of interest. It can further be used to remotely gain an overview of the situation at any time. All data and live pictures are accessible via the online data portal, where detected avalanches are also displayed on the area map.
