# LANDSLIDE MONITORING VAL PARGHERA

Comprehensive monitoring system of the debris flow channel in Val Parghera with automatic warning of the responsible persons via SMS as soon as a predefined limit value is exceeded.

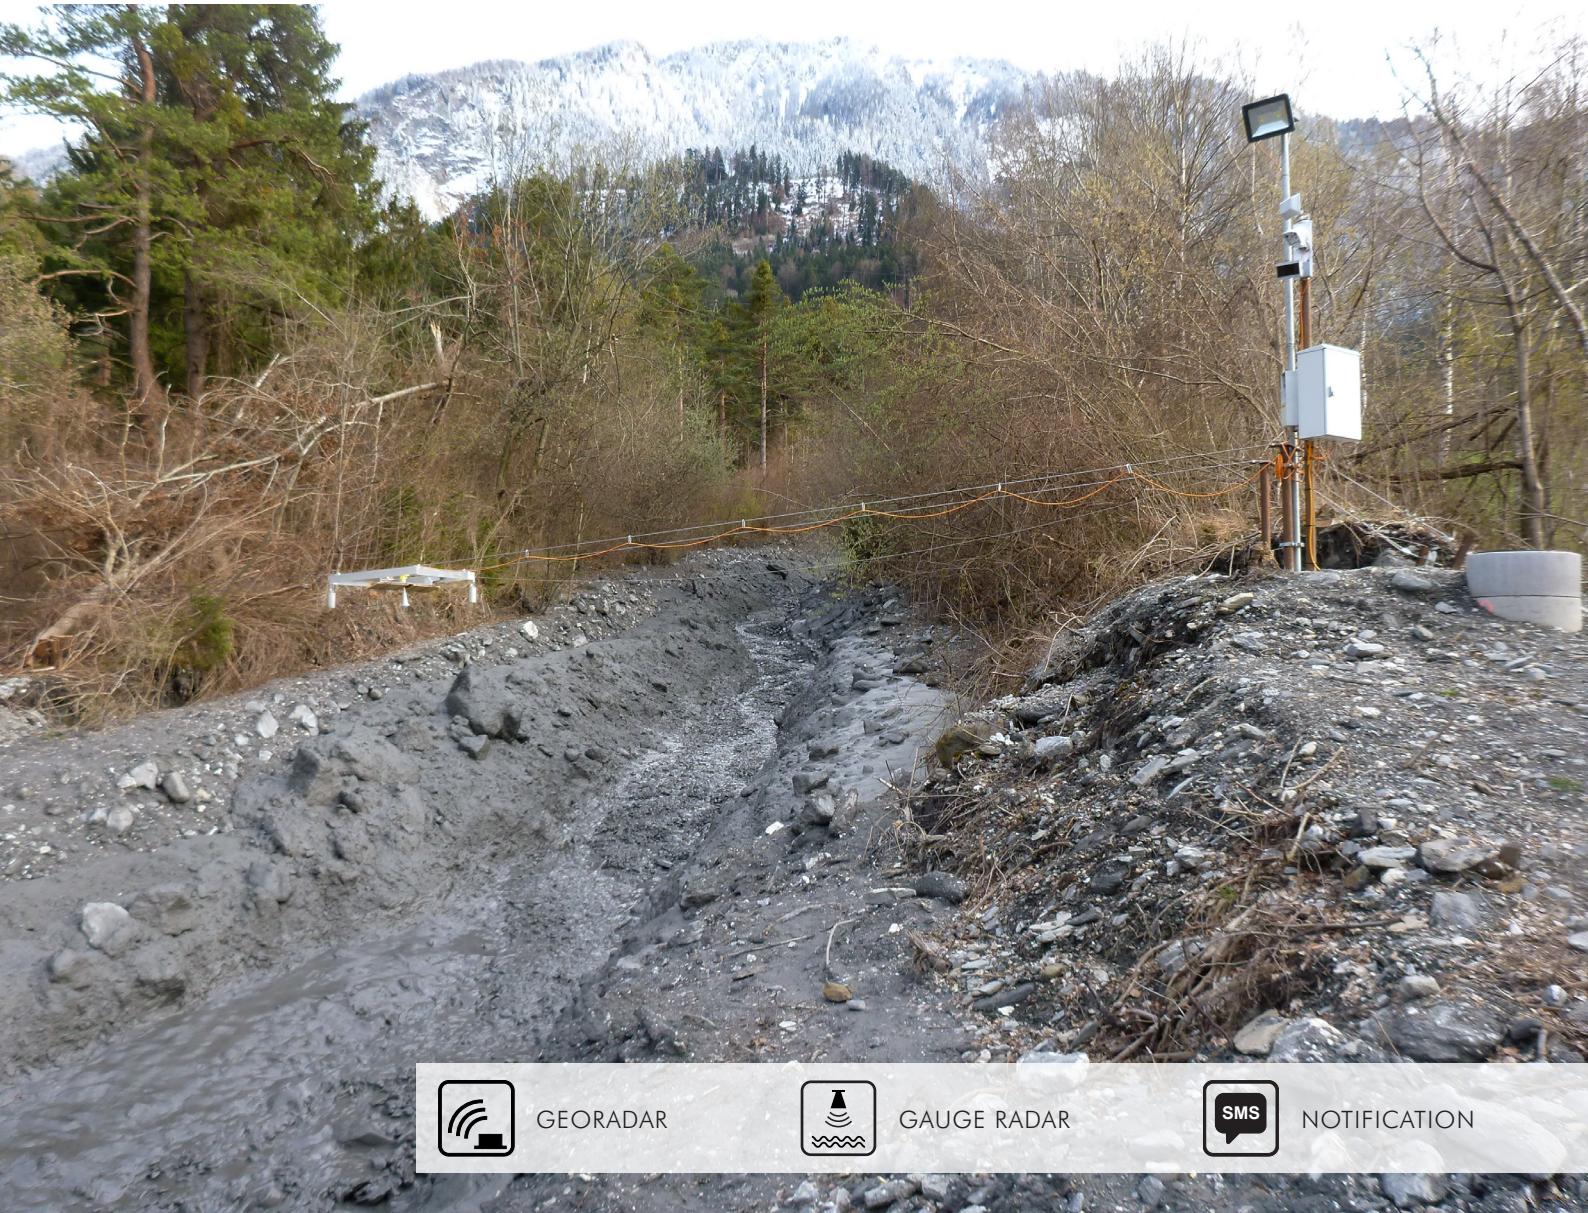
Title Page: View on the radars.

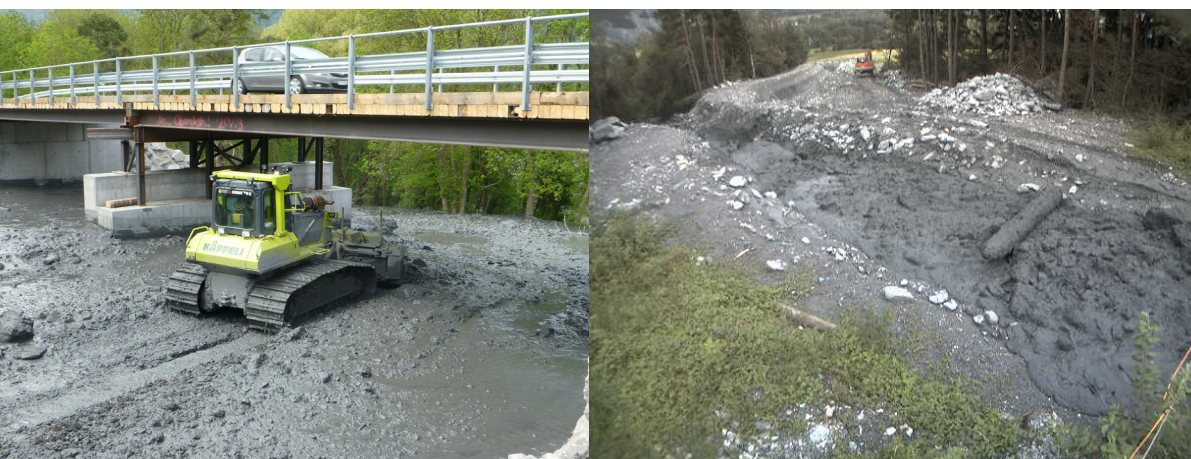
Figure 1: Left: The bridge of the cantonal road was destroyed by the debris flows. An emergency bridge was built as an immediate measure. Right: The debris flow carries earth and rock material, even entire tree trunks, down to the valley.

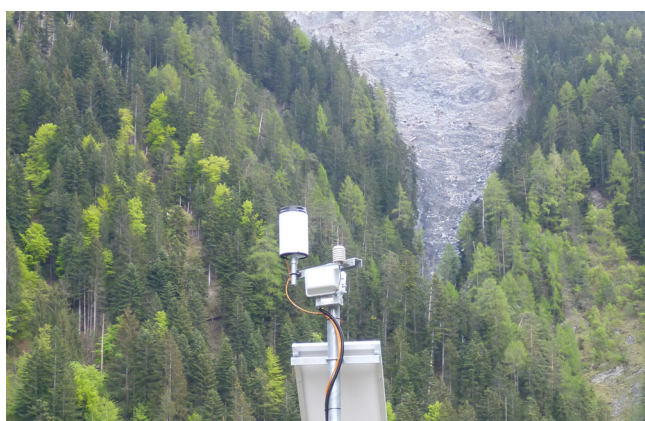
Figure 2: The installed weather station provides local data on precipitation and temperature. This data is important for debris flow forecasts.

Shortly after the first debris flows, Geoprevent installed the first cameras and gauge radars within a short time. A weather station also provided actual precipitation and temperature data for the area. In order to determine the extent of the landslide and to enable an estimation of the

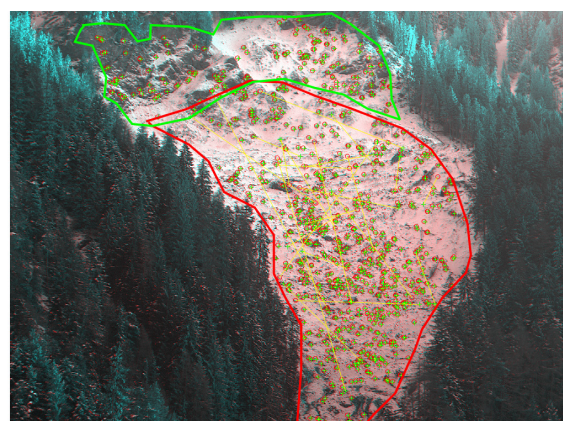
Figure 3: The analysis of the camera images shows flow velocities of the debris flow between 20 cm and 2 m per day.

still moving or unstable material, interferometric radar measurements were carried out in June. The analysis of the camera images as well as the radar data showed that the landslide flowed down the valley with velocities between a few cm and two metres per day. The bedload trap had been extended in case of emergency, because more material continued to accumulate. This material had to be continuously dredged, deposited or liquefied in order to be gradually discharged into the Rhine river. In order to make the work in the bedload trap and the flushing of the drainage channels as efficient as possible and to ensure the safety of the traffic and transport infrastructure, Geoprevent installed additional webcams and gauge radars in August 2013. The authorities were thus able to monitor the landslide, the emergency bridge, the bedload trap and the landslide area at several locations remotely in our online data portal. The online data portal is accessible via desktop, tablet or smartphone and offers an overview of all live and recorded data. In the event of critical level changes, warnings were automatically sent by SMS to enable immediate action to be taken.
