# MONITORING LANDSLIDE MOOSFLUH

The DEFOX<sup>®</sup> deformation camera permanently monitors the Moosfluh landslide area. Thanks to the daily deformation analysis, it is possible to detect as soon as the slide accelerates. This enables early intervention by authorities.

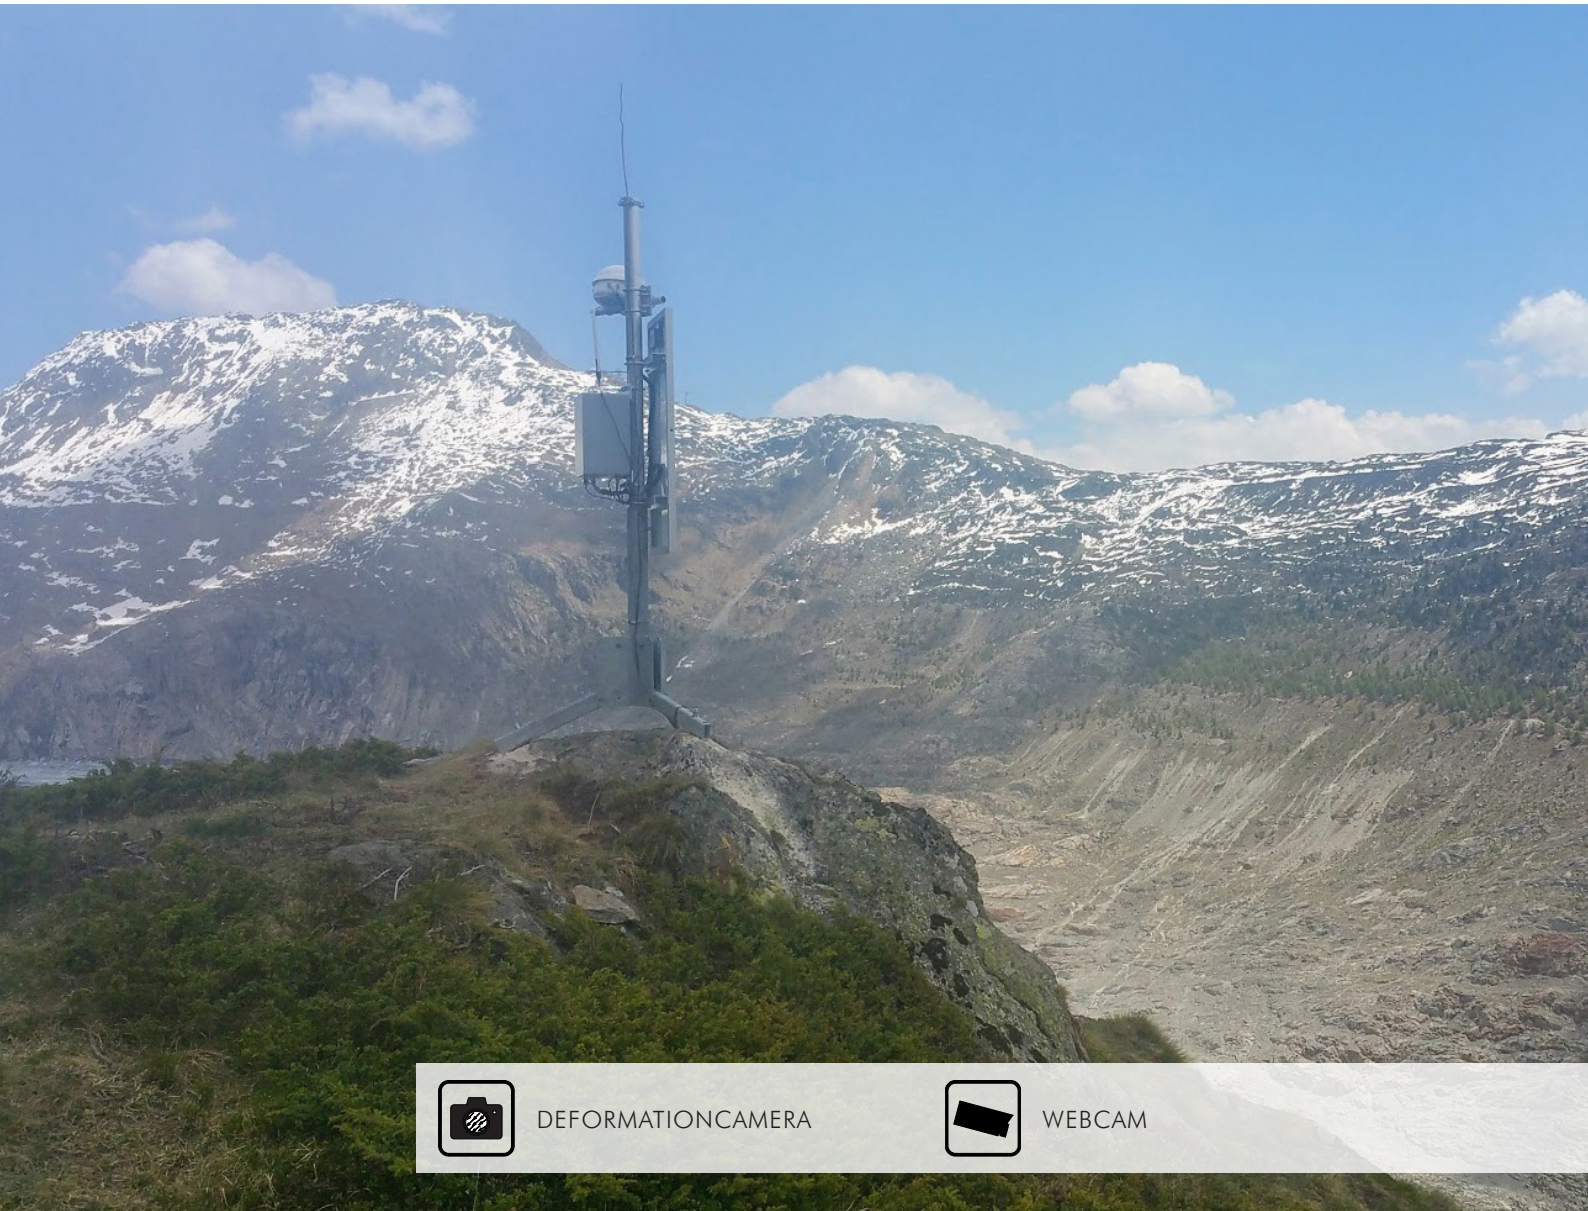
Title Page: Ideal camera view to the landslide area.

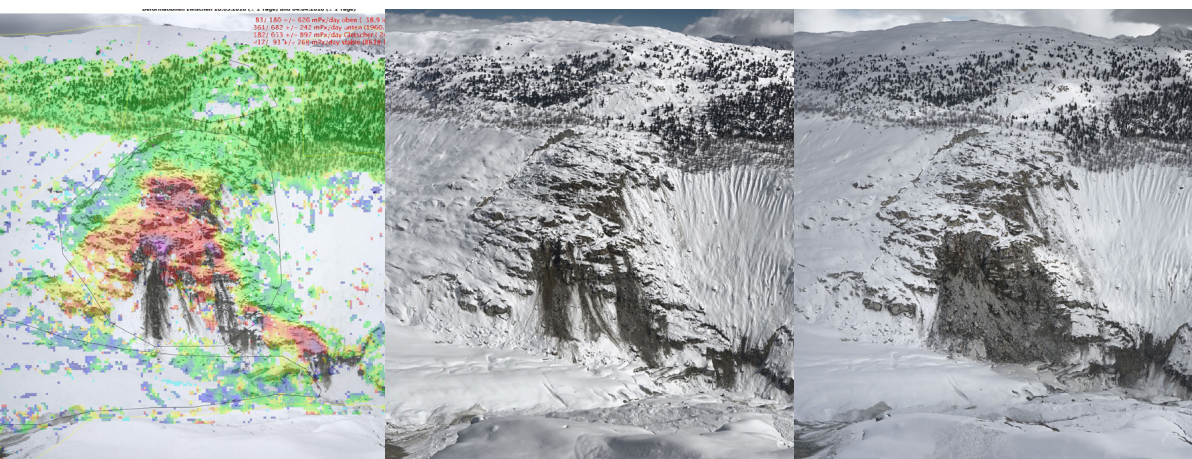
Figure 1: The rock fall in April 2018 (before the rock fall on April 5th: centre; after the rock fall on April 13th: right) had become apparent a few days earlier in the deformation analysis (left) by accelerated velocities.

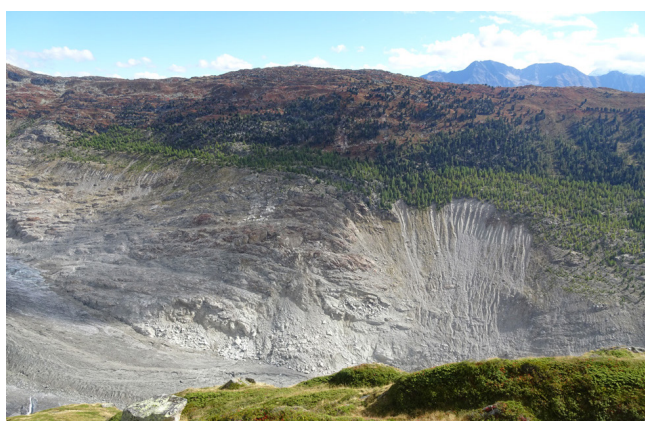
Figure 2: The Moosfluh landslide area: The foot of the slope is destabilized by the retreat of the Aletsch Glacier and the lack of glacier ice.

The Moosfluh is a large landslide area on the left edge of the famous Aletsch Glacier north of Riederalp in Valais, Switzerland. The landslide area extends over a surface of approximately 1 km<sup>2</sup> and a volume of at least 150 million m<sup>3</sup> (Figure 2). Due to the steady retreat of the glacier, the foot of the slope increasingly lacks the stabilizing effect of the glacier ice. This causes slope movement. Since the mid-90s, the unstable slope has been sliding continuously downhill, leading to deep cracks in the terrain and rockfall events. Repeatedly the Moosfluh slides very quickly, up to 80 cm/day. Spontaneous small landslides and break-offs are possible at any time. Consequently, all hiking trails in the area have been closed permanently in 2016. In extreme cases, a large landslide in the Moosfluh can trigger a glacial lake outburst flood (GLOF) from the Gibidum reservoir.

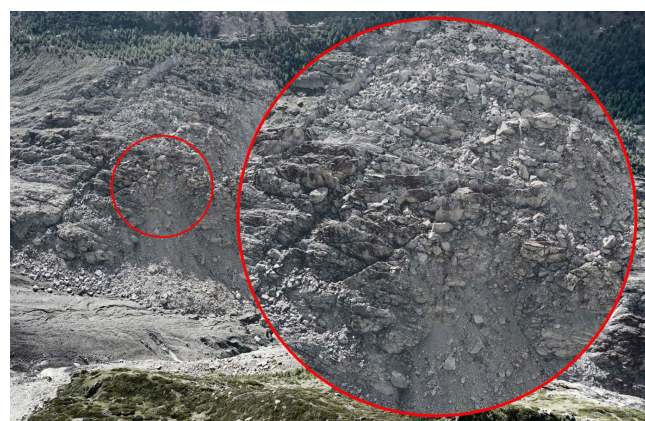
Figure 3: The high-resolution images of the DEFOX<sup>®</sup> PRO webcam are available at any time in the online data portal for authorized users.
