# Monitoring of the Weissmies Glacier before the Failure Event of September 10, 2017 with Radar Interferometry and High-Resolution Deformation Camera

Lorenz Meier<sup>1</sup>, Mylène Jacquemart<sup>1</sup>, Richard Steinacher<sup>1</sup>, Dominik Jäger<sup>1</sup>, Martin Funk<sup>2</sup>

<sup>1</sup> Geopraevent AG, Technoparkstrasse 1, 8005 Zurich, Switzerland  
<sup>2</sup> ETH Zurich, Laboratory of Hydraulics, Hydrology and Glaciology, 8093 Zurich, Switzerland

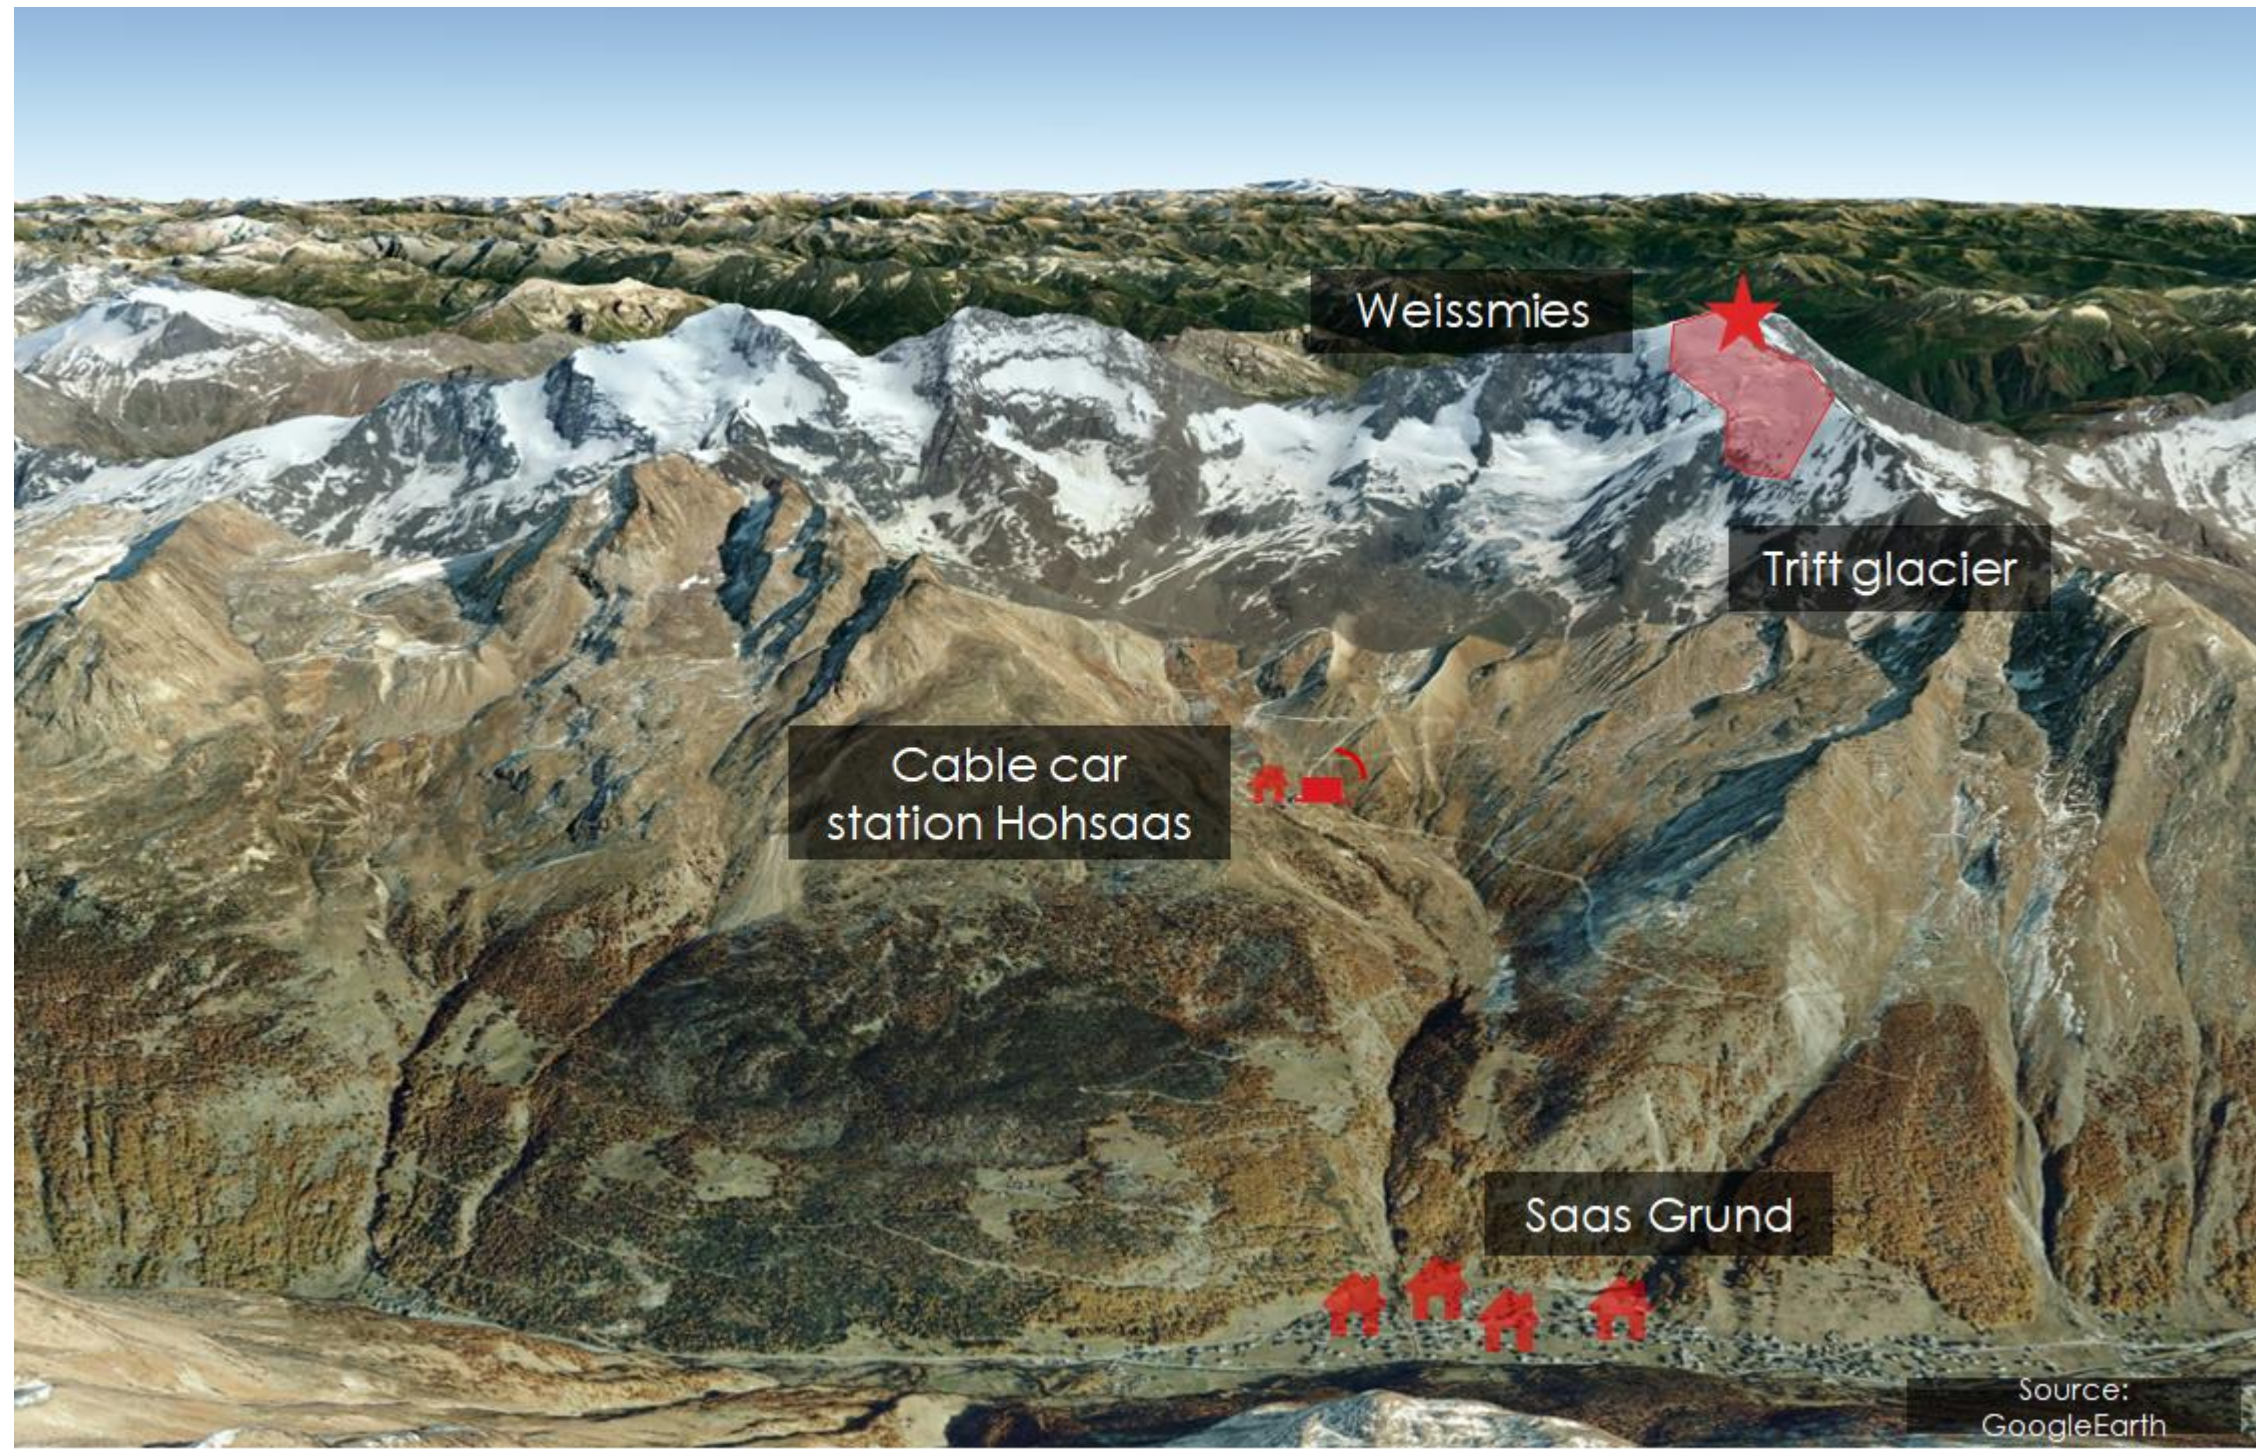
Figure 1: Saas Grund at the base of Weissmies: The interferometric radar and the high-resolution camera are mounted in combination or alternately at the cable car station Hohnsaas.

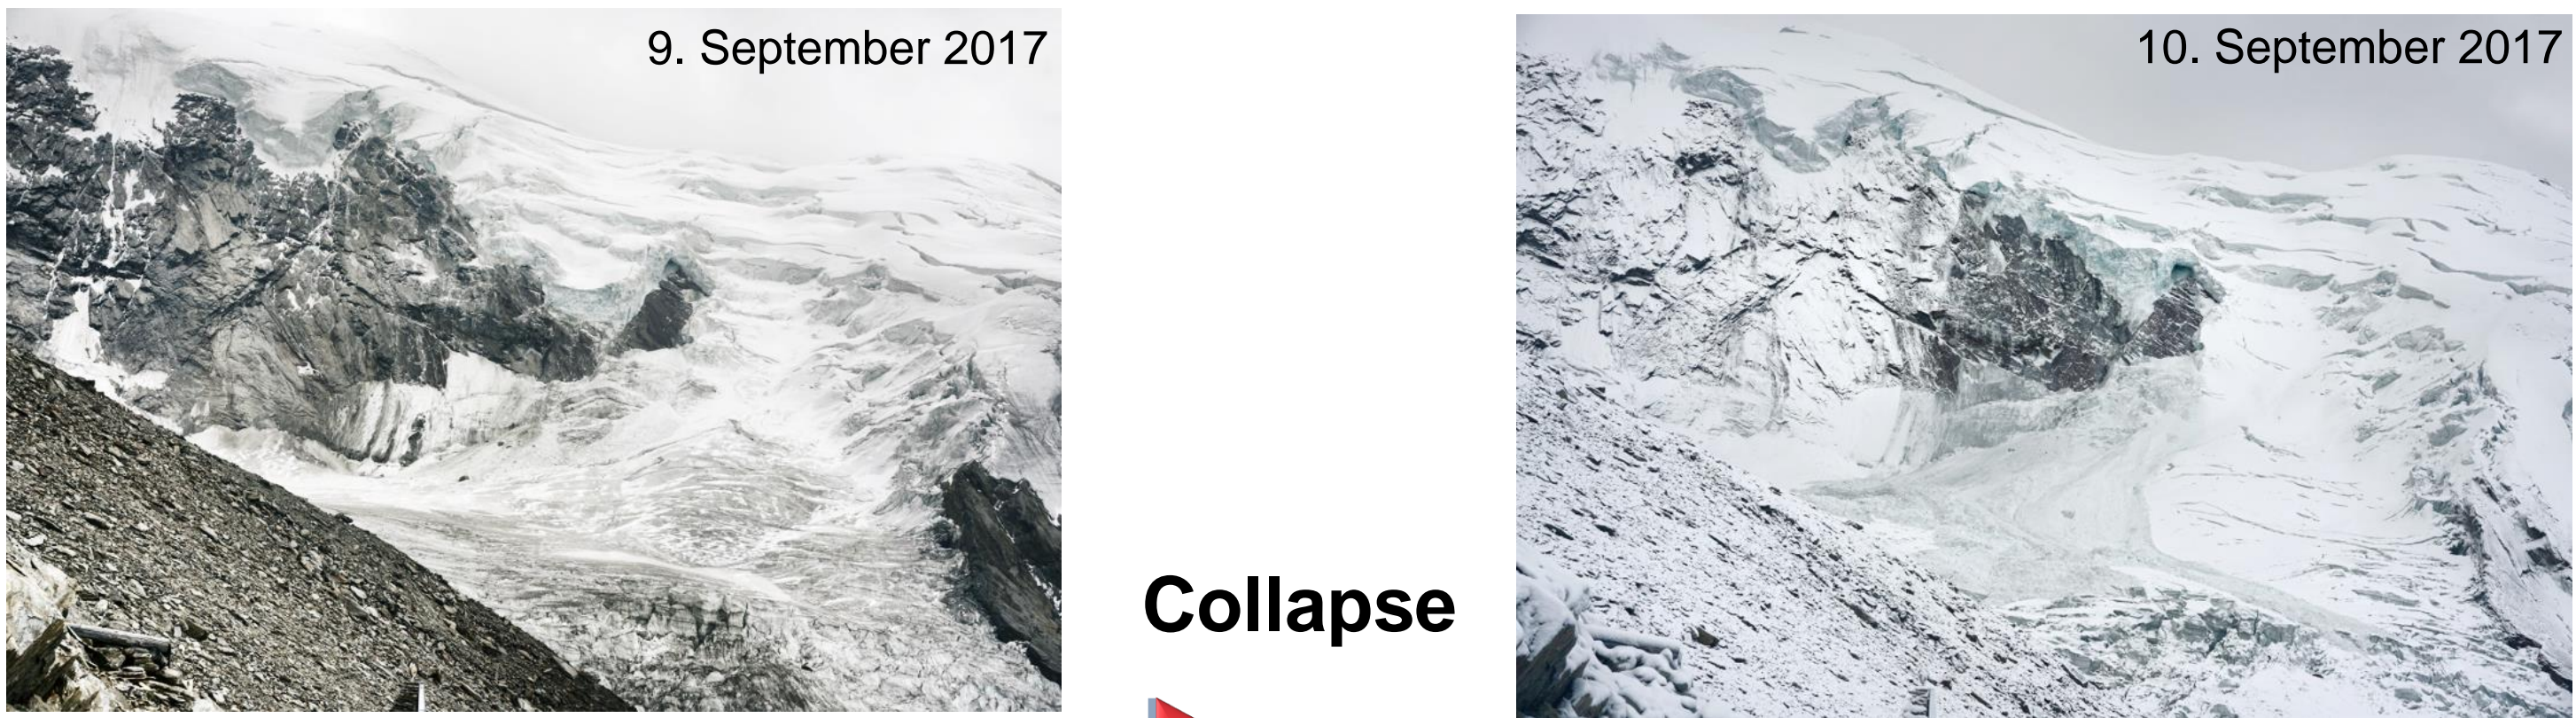
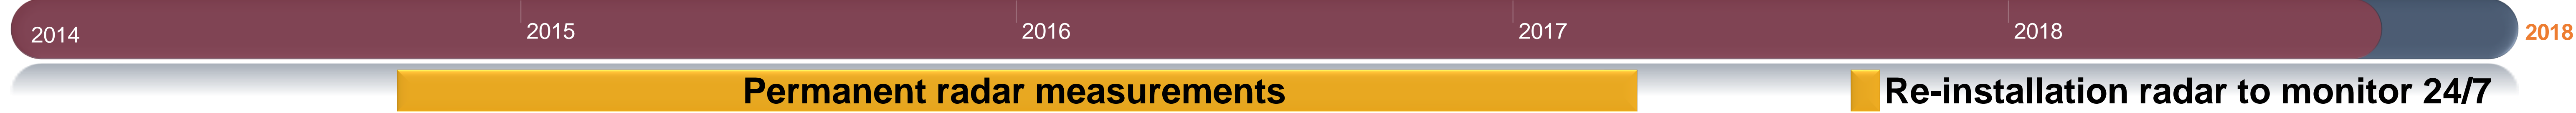
In August 2017, a **pronounced acceleration** was observed on the **camera analysis**. Therefore, we re-installed the interferometric radar. The radar measurements confirmed the 5-fold increase in surface velocities. Around noon on September 9, extrapolation of the inverse velocities predicted a large failure within approximately 24 hours. As a consequence, 220 inhabitants of Saas Grund were evacuated. In the early morning of September 10, the collapse of a total of approximately 300'000 m<sup>3</sup> happened, luckily not at once but in several smaller portions during about 10 minutes.

Figure 3: An image processing algorithm **automatically** determines the surface deformations based on the camera pictures.
