Monitoring of the Weissmies Glacier before the Failure Event of September 10, 2017 with Radar Interferometry and High-Resolution Deformation Camera

Lorenz Meier¹, Mylène Jacquemart¹, Richard Steinacher¹, Dominik Jäger¹, Martin Funk²

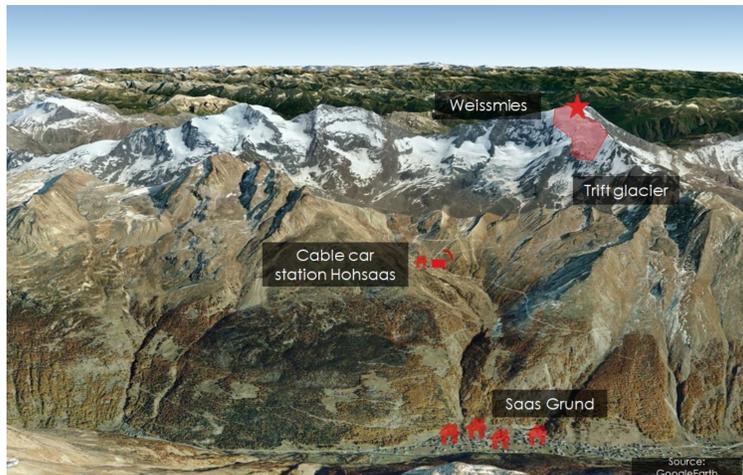
Figure 1: Saas Grund at the base of Weissmies: The interferometric radar and the high-resolution camera are mounted in combination or alternately at the cable car station Hohnsaas.

A large part of the glacierized northwest face of Weissmies recently became unstable.

The situation at Weissmies is critical because the glacier immediately below the unstable part is frequently travelled by mountaineers on their way to the summit of Weissmies. Besides that, large avalanches with several 100'000 m³ off the northwest face of Weissmies pose a threat to infrastructure and people in the valley.
