REAL-TIME RADAR AVALANCHE DETECTION OF A LARGE DETECTION ZONE FOR ROAD SAFETY IN NORWAY

ABSTRACT: The project involves testing a long-range and wide-angle Doppler radar for detection of avalanches, as a part of an early warning system planned for County Road 293 at Holmbuktura, Troms, Northern Norway. The avalanche-prone road through Holmbuktura is the only access road to an area inhabited by approx. 100 permanent and 100 weekend inhabitants. The average traffic through Holmbuktura is around 200 vehicles per day. Possible mitigation measures include an 800-1'000 m long tunnel or an avalanche protection gallery of similar length, both involving costs between 30 and 35 Mio Euro. The Norwegian Public Roads Administration (NPRA) is therefore evaluating cheaper solutions with a better cost-benefit ratio, among them long-range and wide-angle Doppler radars with automatic road closure to protect vehicles from being caught by avalanches. During the two test winters, Long-range, wide-angle Doppler radar has proven to detect avalanches with sufficient warning time for road closure

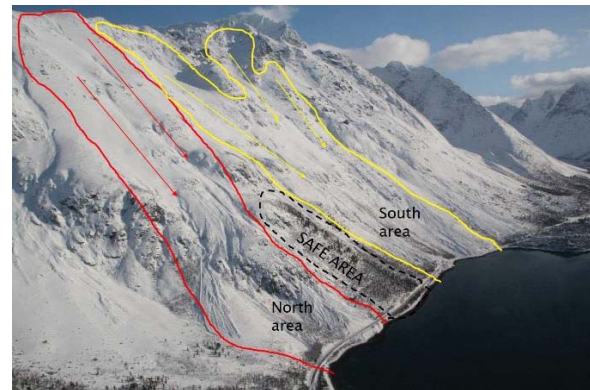
Figure 1: The avalanche area consists of two main avalanche gullies: the north gully and the south gully. Between them is a safe spot with no avalanche activity registered. Photo: Ole-André Helgaas.

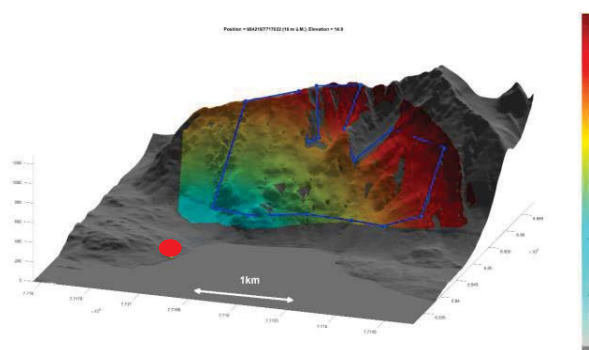
Figure 2: The simulated radar coverage is shown. Coloured areas are monitored by the radar. Colour indicates distance in meters. The red dot is the position of the radar. Figure is taken from Geopraevent project report (Meier 2018).

The radar has a range of approx. 4 km and a field-of-view of 90 degrees horizontally and 15 degrees vertically (Meier 2018), which covers most of the avalanche area in Holmbuktura. The radar should detect any avalanches of size 2 or larger (EAWS classification) according to detection criteria given in the project. The position of the radar was determined based on both visibility of the release zones and access to permanent power supply (figure 2).

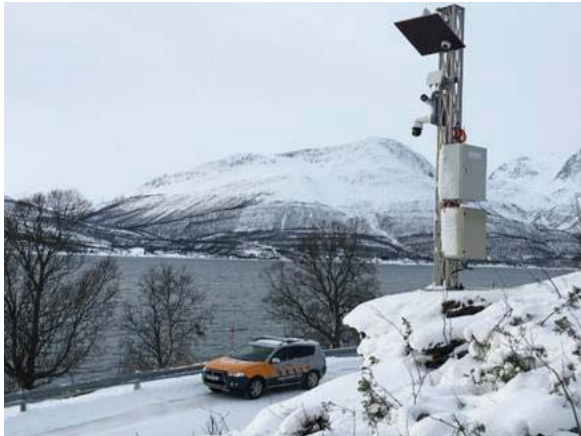
Figure 3: Radar installation (February 2017). To verify detections, a remotely controllable PTZ camera and a thermal camera were installed additionally. Photo: Andreas Persson

The radar was installed in February 2017. To verify detections, we also installed a remotely controllable PTZ camera and a thermal camera. The radar system sent SMS messages immediately after it detected an avalanche. A few minutes after the avalanche, the radar sent another SMS with an estimate if the avalanche reached the road or not. The goal of this service was to provide road personnel with an early warning, but also to evaluate the implementation of traffic lights with automatic road closure and reopening, which is planned for 2019.

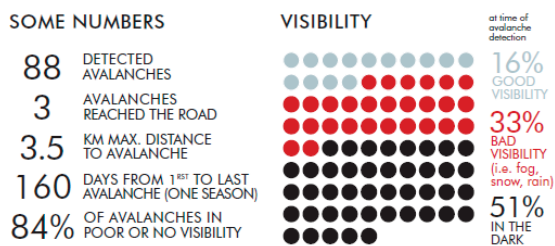
AVALANCHE RADAR HOLMBUKTURA: FEBRUARY 2017-MAY 2018

Figure 3: Some numbers from the project report provided (Meier 2018).

The radar system successfully detected 88 small to large avalanches during the two test winters (Meier, 2018). Of these avalanches, three hit the road. 16 % of all avalanches were detected in good visibility, 33 % in poor visibility due to bad weather conditions, and 51 % of the detections were made in dark conditions (Meier, 2018).

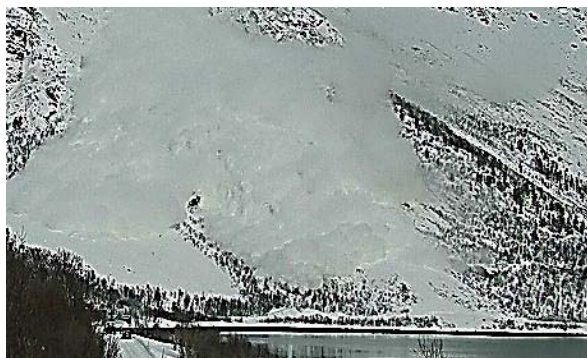
Figure 5: Example of a live photo documentation of an avalanche just before hitting the road in the northern avalanche gully on the 29th of mars 2018. The PTZ camera connected to the radar documents the event.

Furthermore, as many of the local inhabitants had previously been sceptic to this type of low-cost mitigation, the test project has also provided the local population with some more knowledge and optimism for early warning system like the radar project. For the first time since the road was built in 1970, there was live photo-documentation from actual avalanches taking place.
