## ROCK AVALANCHE AND DEBRIS FLOW ALARM SYSTEM BONDO

Comprehensive rock avalanche monitoring at Pizzo Cengalo and debris flow alarm system with automatic road closure in Bondo village.

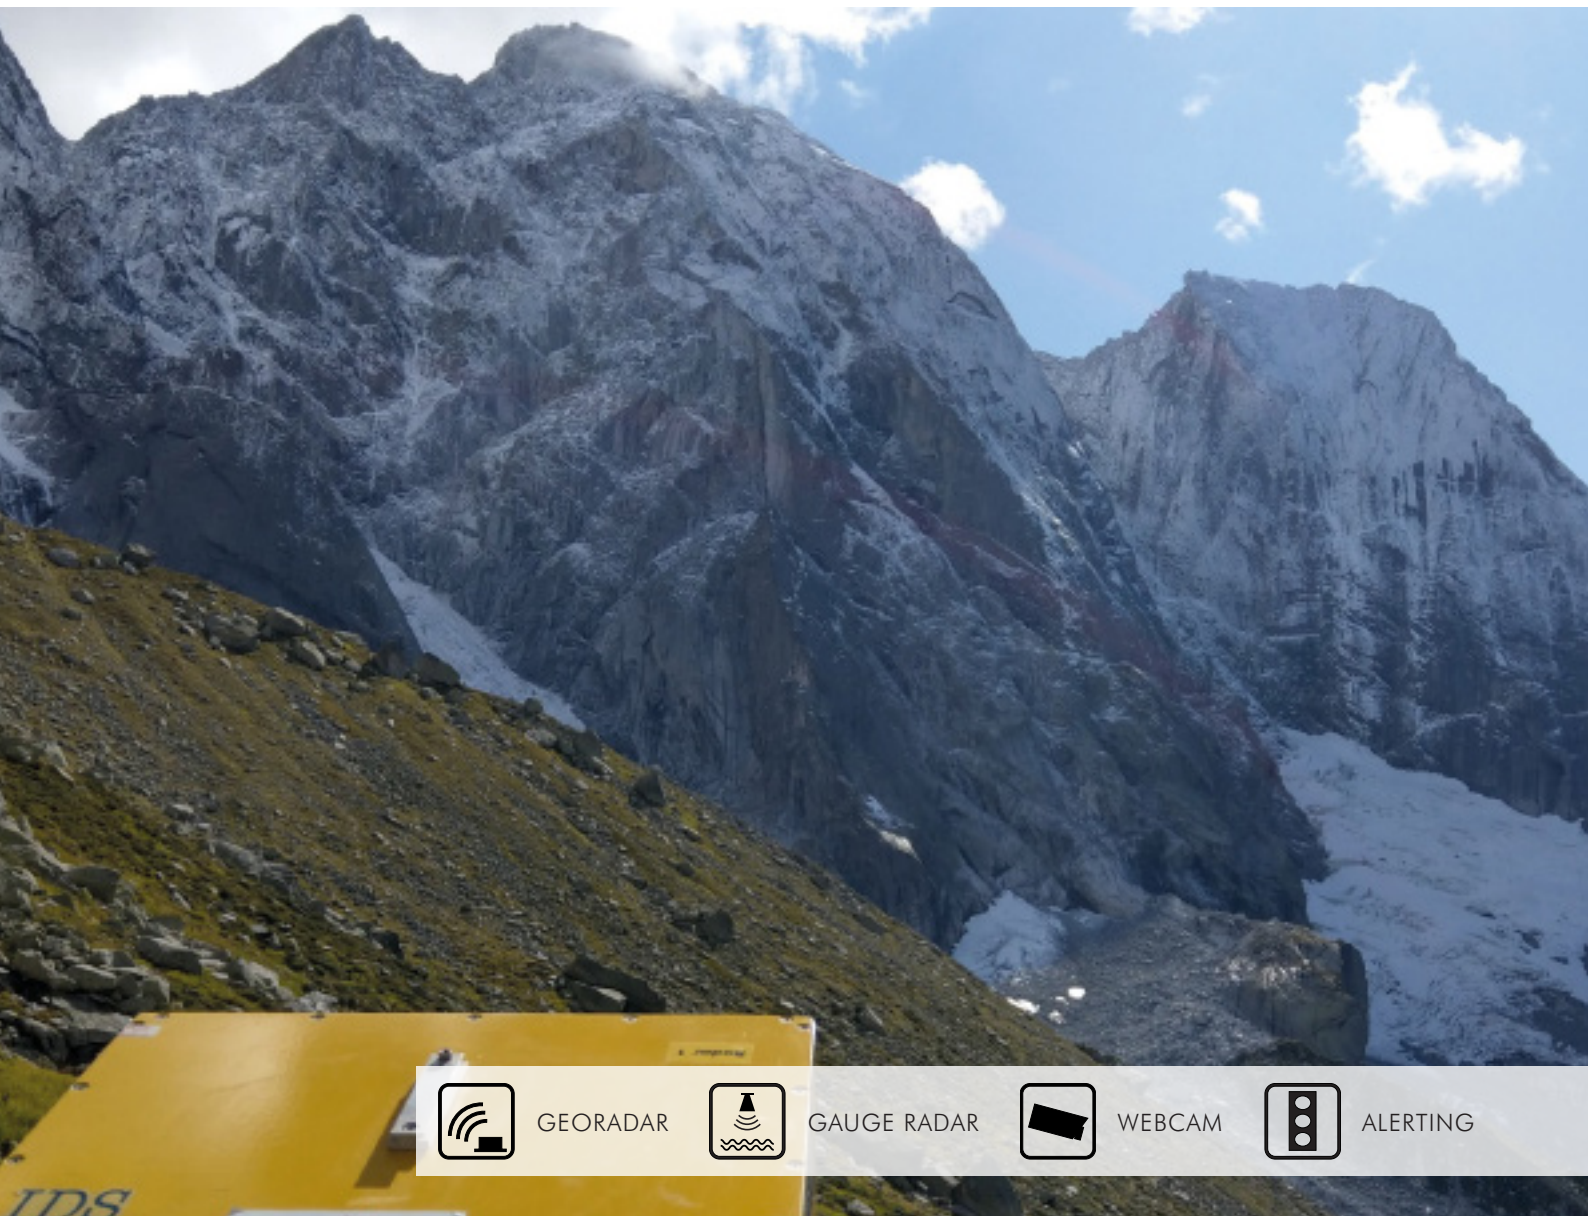
Title Page: Georadar to monitor Pizzo Cengalo.

Additionally, we set up a warning system to monitor Pizzo Cengalo around the clock by georadar (station C). The interferometric georadar continuously scans the rock face and detects smallest surface movements on a scale from millimetres per year to meters a day. The radar operates reliably at a safe distance in all weather and visibility conditions. Automated deformation analysis identifies acceleration areas within the rock face and enables early recognition of potential instabilities. Collapse estimations can be drawn from analysing the inverse velocities of critical rock areas combined with expert judgement. Event predictions including approximate timings have proved correct in several cases, e.g. for the rockfall event of September 15, 2017, with expected failure at night. The georadar warning system allows to plan and implement appropriate protection measures early (e.g. evacuation) and guarantee safety for the village.

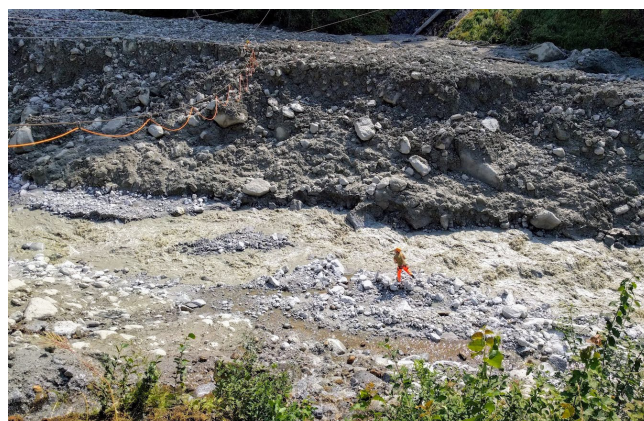
Figure 3: Gauge radar station (station A) across the Bondasca river with several meters debris flow deposits in August/September, 2017.

The existing alarm station (station A) was repaired and extended. In addition, we installed a second alarm station upstream (station B) allowing increased warning times. Station A provides approximately two minutes and station B approx. four minutes warning time before the debris flow
