## AN AUTOMATED ALARM AND WARNING SYSTEM FOR THE BIS GLACIER ICEFALL, SWITZERLAND, USING A 5 KM RADAR AND HIGH-RESOLUTION DEFORMATION CAMERAS

**ABSTRACT:** We presents results from a novel warning and alarm system aimed at predicting and detecting ice avalanches starting on the steep icefall on Bis glacier near the municipality of Randa, canton of Valais, Switzerland. Every 15-20 years, depending on snow conditions, avalanches starting in the icefall reach the valley bottom, where they impact road and railway. Operational since 2017, the system uses two high-resolution cameras to measure the surface velocities in the icefall to predict breaking off of large ice volumes. In addition, a Doppler radar system with a range of 5 km detects the moving avalanches after they have released, regardless of whether they consist of snow, ice, or a combination of both. The system is set up to automatically close the road and stop trains in the valley, a feature that will be fully implemented in late 2018.

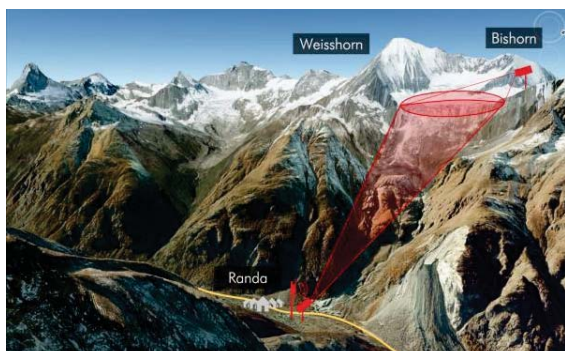
Figure 1: The municipality of Randa in the Matter valley at the base of Weissshorn and Bishorn. The doppler radar and one of the high-resolution cameras are mounted on the opposite side of the valley. The second camera is installed above the icefall, providing a good view of the sérac zone from an elevated position.

We installed the Doppler radar in the valley bottom, from where it permanently monitors the critical part of the glacier and the runout zone between 1800 and 3300 m a.s.l., at distances of up to 5 km (Figure 1). Any avalanche activity in this zone is immediately detected by the radar. The Doppler radar emits electromagnetic waves of a set frequency, and measures the frequency change of the reflected signal that is caused by moving objects in the target area. If an avalanche approaches the radar, the reflected signal will be of a higher frequency. Advanced algorithms analyze the signal in real time and classify the targets based on different criteria into avalanches or other objects (like rain drops, helicopters, etc.). The doppler radar has a 10 m range resolution, which allows us to precisely track avalanches on their way down the mountain. The warning time for the road and the railway is limited: it takes a car about 30 s to pass through the hazard zone, while a train is exposed for about 60 s. The system must therefore trigger the alarm no later than 30 s before the avalanche reaches the road and 60 s before the avalanche reaches the railway. This requires deciding about whether or not to trigger a closure when the avalanche is still high up on the slope, where it is not clear whether it will reach the valley bottom or not. In fact, most avalanches stop far above the road and railway. In order to prevent unnecessary closures, we apply two strategies:

In order to identify instabilities in the icefall at an early stage, we installed two high-resolution cameras (42 megapixels) to monitor the glacier (Figure 1). One camera is located north of the icefall at 3400 m a.s.l., looking at the sérac zone from an elevated position. The other camera is installed at the radar location, aimed towards the glacier at an oblique angle from below (Figure 2). The system captures several images per day and immediately sends them to a server, where the surface motion is automatically determined on a daily basis using 2-D cross-correlation analysis. The results of this analysis are then immediately made available to local authorities on a password protected website (Figure 4). Camera images can be georeferenced and converted to real-world deformations (meters/day), however, the relative changes from one day to the next are sufficient to detect accelerated ice surface areas and assess the situation in the steep glacier zone. If a large unstable ice mass is detected in the icefall, authorities have ample time to monitor the situation and plan emergency measures. Detection of glacier instabilities in the steep glacier zone relies on optical feature tracking which requires good visibility to the target area and stable features. An all-weather alternative would be to use a ground-based interferometric radar system (Margreth et al., 2017), but the cameras are substantially more cost-effective and provide sufficient long-term monitoring capabilities in absence of a dire emergency.

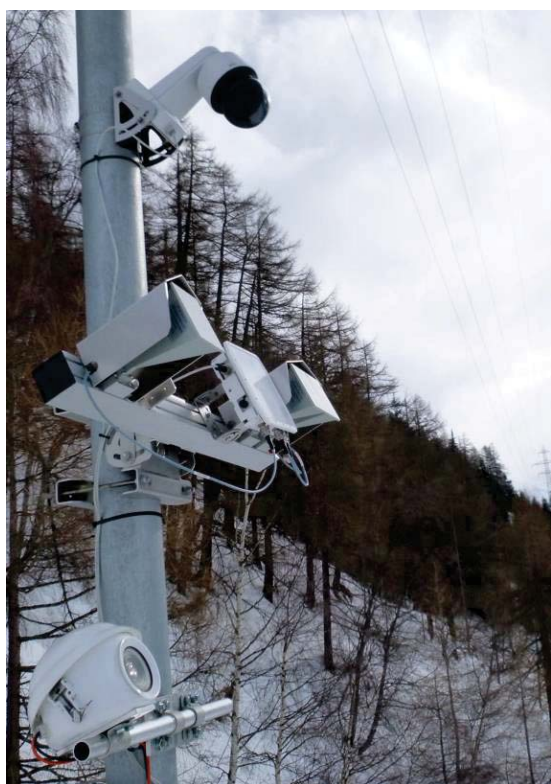
Figure 2: Radar systems (middle) and high-resolution camera looking up at Bis glacier near the municipality of Randa.
