DIGITAL PROTECTION NET OVELLA

Digital monitoring of rockfall protection nets with motion sensors
in Ovella.

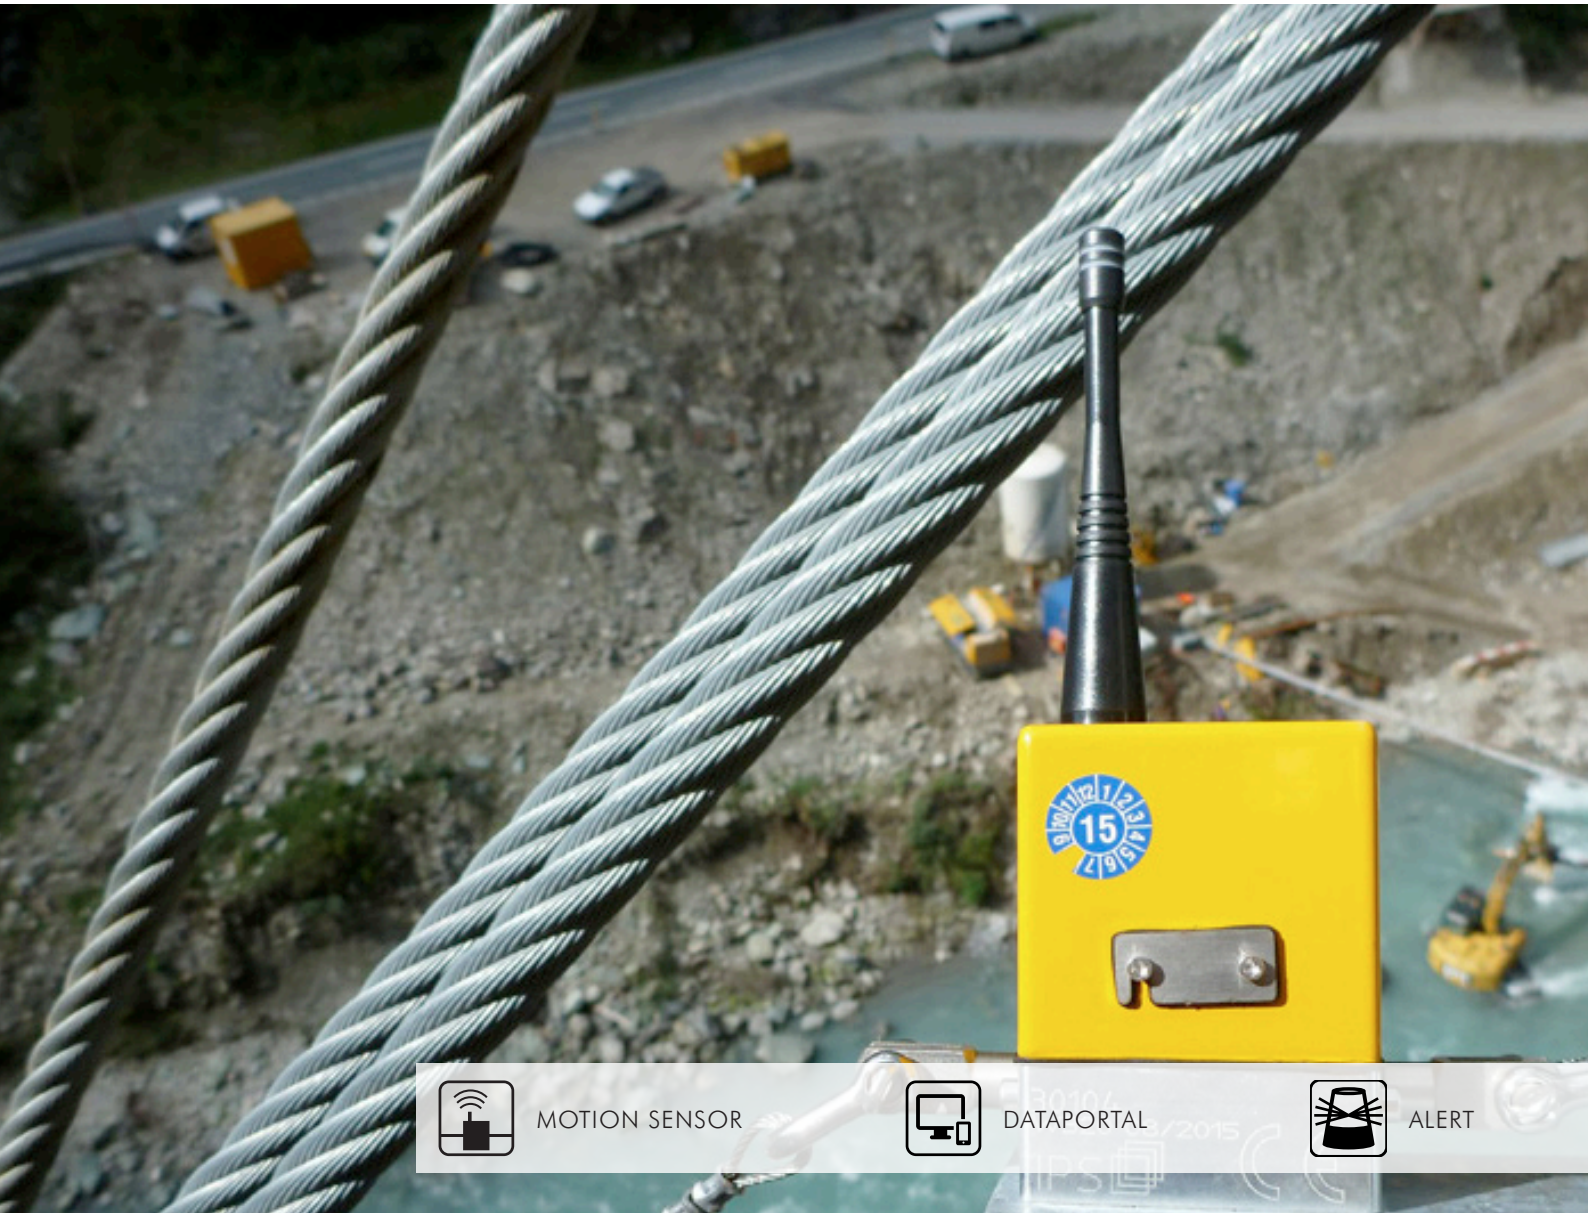
Title Page: Sensors above the construction site near Ovella.

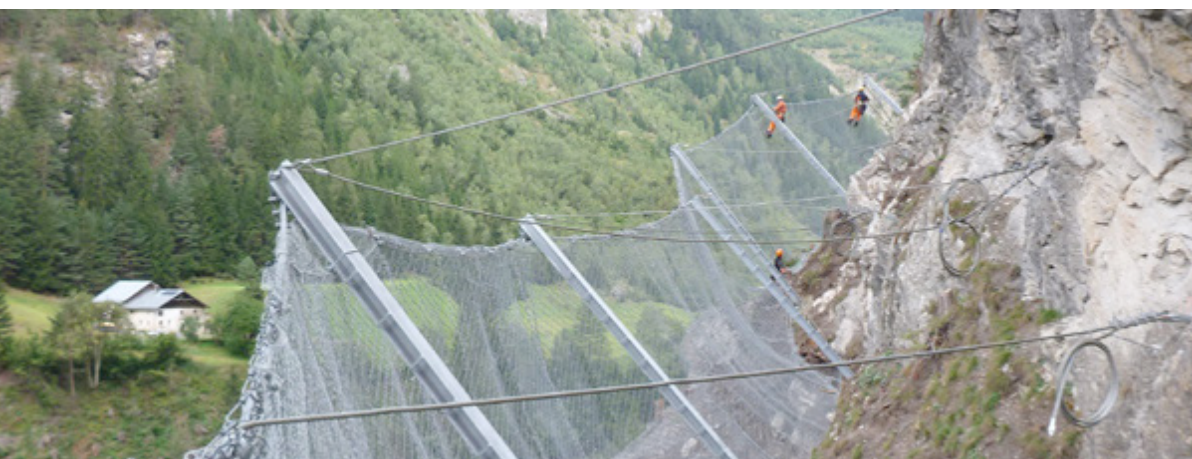
Figure 1: On site installation. The sensors are mounted on the ends of the net supports, keeping them at a distance from falling rocks.

More than 100 motion sensor in combination with trigger lines have been installed. The sensors of the type ImpactSentinel monitor the state of the nets and provide the responsible geologists with live data about the state of the nets, warning them in case large rock fall occurs. The sensors have been installed on the Austrian side of the river Inn, while the base station receives their signals on the Swiss side of the river, and several relay stations ensure a flawless transmission. If boulders or a large amount of rocks strike a net it will bulge, causing the trigger lines to extract the pull-out pins on the sensor, triggering the alarm.

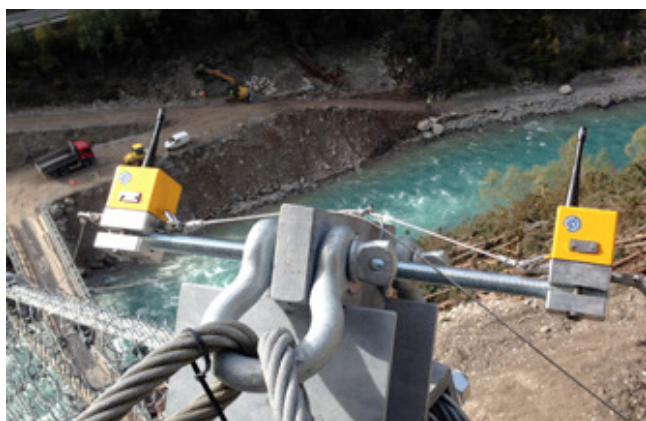
Figure 2: 1.2 km of monitored nets protect the construction site below.

The new river power plant currently under construction between the Austrian and the Swiss border in the Lower Engadin Valley is the largest new power plant being built in the Alps in recent years (constructor: Gemeinschaftskraftwerk Inn GmbH). Roughly 1.2 km of protection netting was installed in order to protect the construction site for the weir, located at the base of the Kitzmaiss wall, from rockfall. To maximise safety the protection nettings needed to be monitored with sensors.

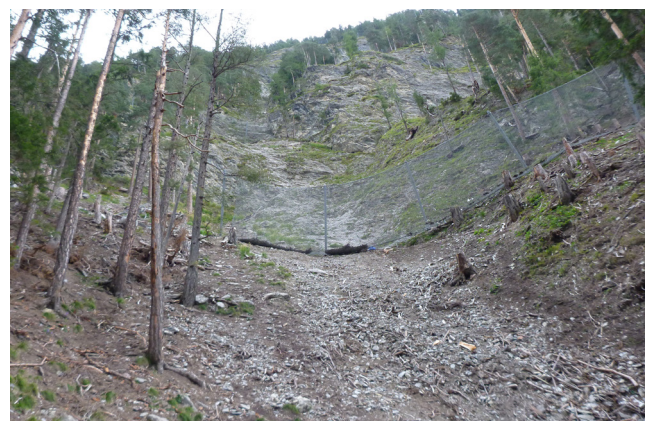
Figure 4: The construction site is threatened by two main gullies. Multiple lines of protection netting are designed to keep rocks from reaching the valley bottom.
