## MONITORING BIS GLACIER RANDA

The monitoring of the Bis glacier is divided into two subsystems: a warning system for long-term observation of the steep glacier slope and an alarm system for ice avalanches resulting from glacier collapses.

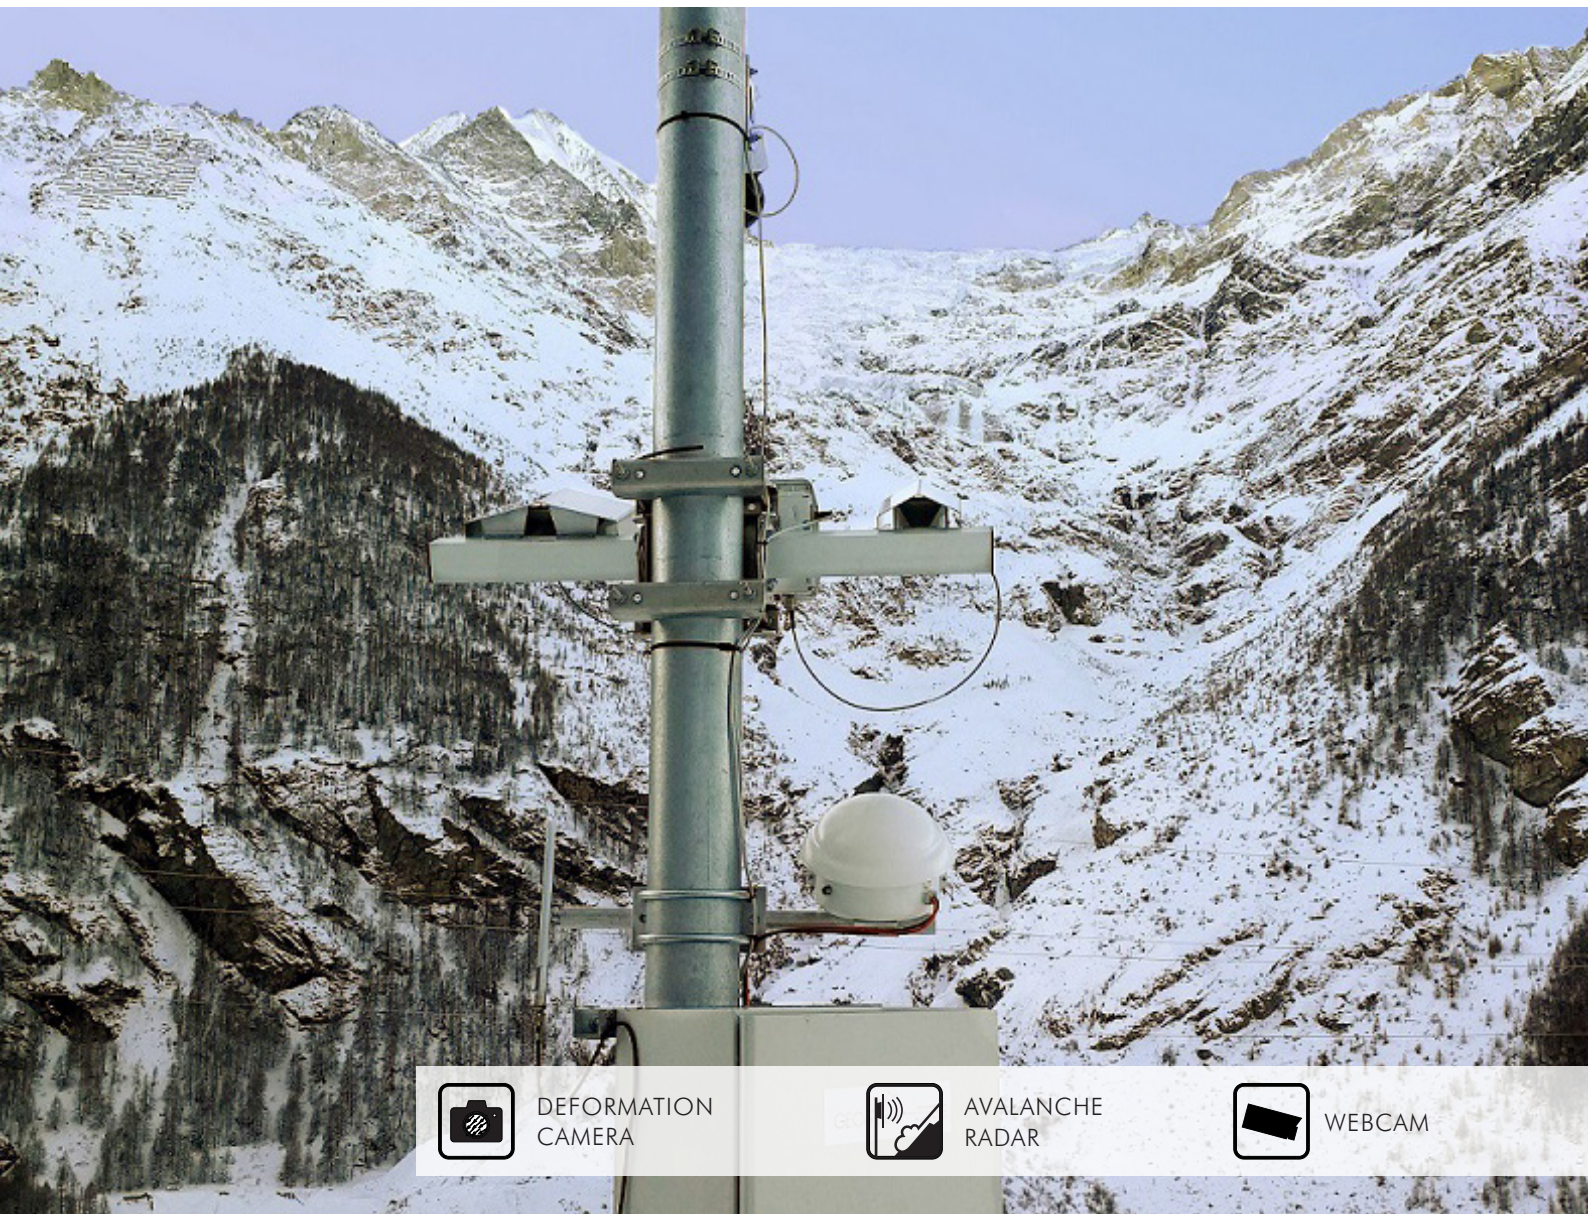
Title Page: A high-resolution camera is installed at the valley bottom and observes the steep part of the Bis glacier.

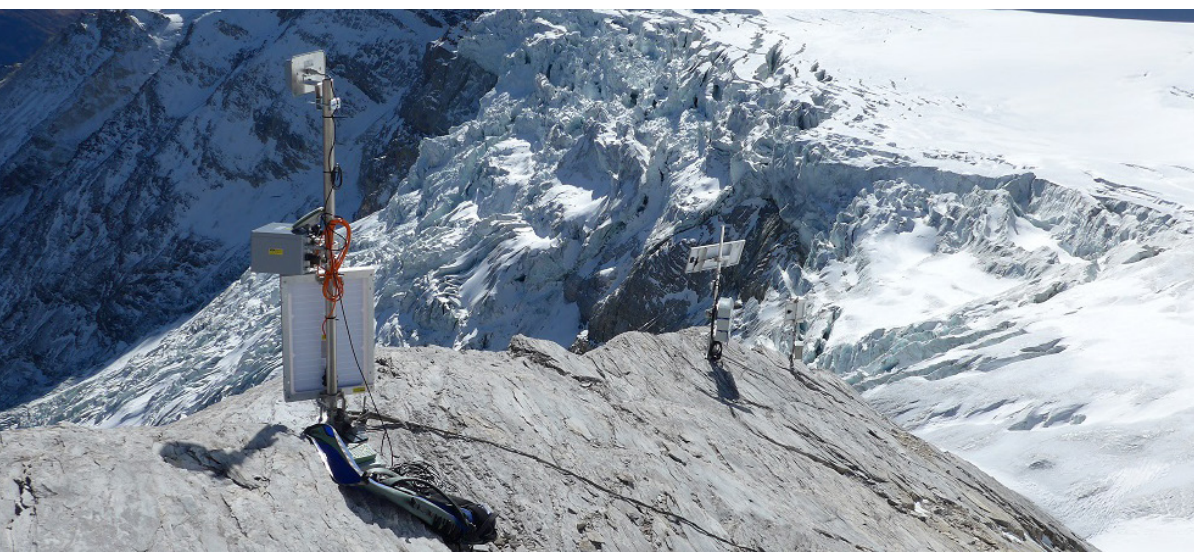
Figure 1: Several generations of cameras of the escarpment: Our station for the upper deformation analysis is in the foreground.

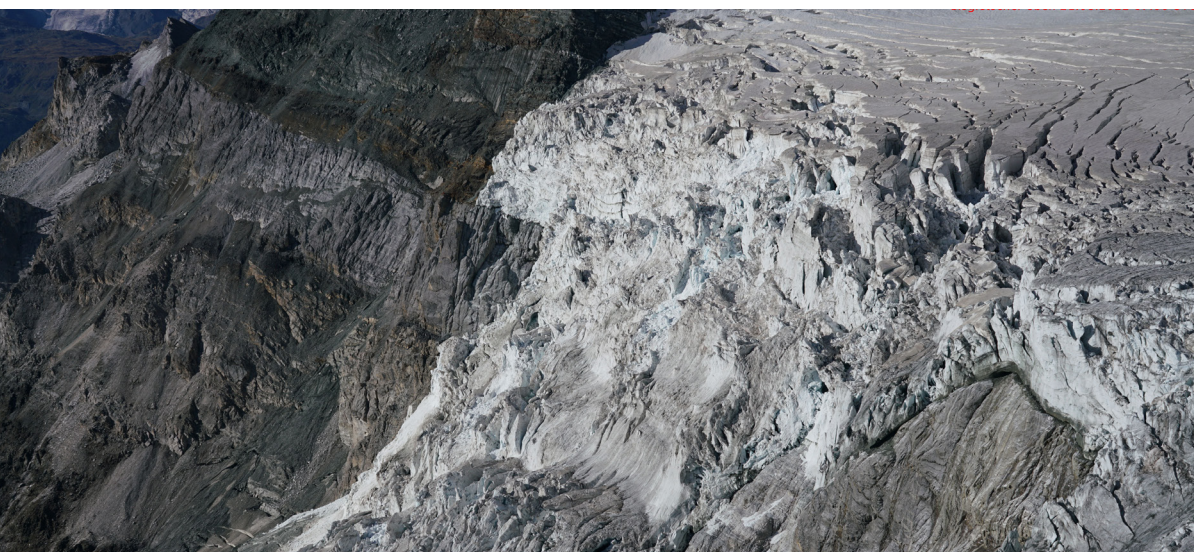
Figure 5: High-resolution image of the camera from 21 August 2022 from the escarpment.
